## General Information

Date & Time: 26, Jan, 2026 10:57

<b>Make</b>	Toyota	<b>Model</b>	Vios
<b>YOM</b>	2025	<b>Odo Meter Reading</b>	25,499
<b>Registration No.</b>	NHS5407	<b>Chassis No.</b>	PA1B137R4264834
<b>CC</b>	1.3	<b>Transmission</b>	CVT
<b>Fuel Type</b>	Gas	<b>Type of Body</b>	Sedan
<b>Colour</b>	Silver

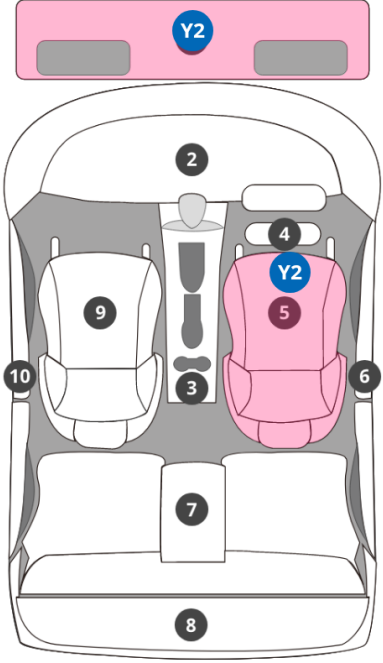
<p><b>A</b> : Scratch <b>AU</b> : Scratch &amp; Dent <b>B</b> : Modified <b>C</b> : Corrosion <b>G</b> : Stone chip <b>P</b> : Faded <b>S</b> : Rust <b>SC</b> : Rust &amp; Corrosion <b>U</b> : Dent <b>X</b> : Defective <b>Y</b> : Crack, Gap</p>
<b>Remarks</b> Ceiling - Grime - Small / (R) Front Seat - Grime - Small	<b>Remarks</b> (R) Step - Repair Traces - Yes / Trunk Hood, Rear Gate - Repair Traces - Yes / (R) Rear Door - Repair Traces - Yes / (R) Front Fender, Molding - Scratch - Minimal / (R) Step, In-panel, Side Spoiler - Repair mark - Yes / (R) Step, In-panel, Side Spoiler - Scratch - Minimal / (R) Front Door, Molding - Scratch - Minimal / (R) Rear Door, Molding - Scratch - Minimal / (R) Rear Fender, Molding - Repair mark - Yes / (R) Rear Fender, Molding - Scratch - Minimal / Rear Bumper, Lamps, Panels - Scratch - Minimal / Trunk Hood, Rear Gate - Scratch - Minimal / (L) Rear Fender, Molding - Scratch - Minimal / (L) Rear Door, Molding - Scratch & Dent - Minimal / (L) Mirror - Scratch - Minimal / (L) Front Door, Molding - Scratch - Minimal / (L) Step, In-panel, Side Spoiler - Scratch - Minimal / (L) Front Fender, Molding - Scratch - Minimal / Bonnet, Headlight - Scratch - Small / Front Bumper, Grille, Lamps - Scratch - Minimal
