## General Information

<b>Make</b>	Toyota	<b>Model</b>	Vios
<b>YOM</b>	2025	<b>Odo Meter Reading</b>	43,325
<b>Registration No.</b>	BAG6991	<b>Chassis No.</b>	PA1B18F33R4274572
<b>CC</b>	1.3	<b>Transmission</b>	CVT
<b>Fuel Type</b>	Gas	<b>Type of Body</b>	Sedan
<b>Colour</b>	Black

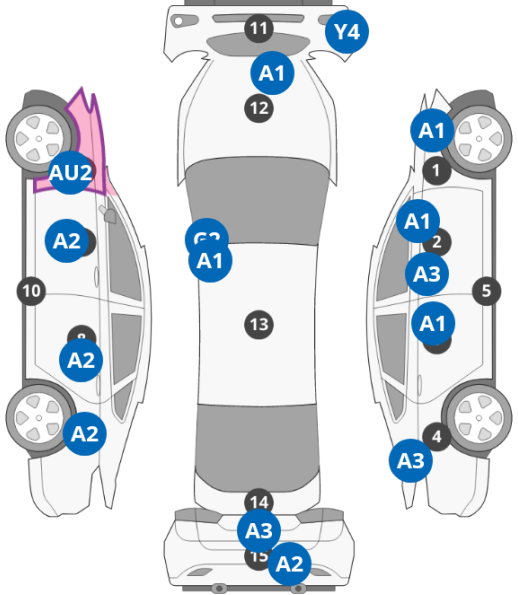
<p><b>A</b> : Scratch <b>AU</b> : Scratch &amp; Dent <b>B</b> : Modified <b>C</b> : Corrosion <b>G</b> : Stone chip <b>P</b> : Faded <b>S</b> : Rust <b>SC</b> : Rust &amp; Corrosion <b>U</b> : Dent <b>X</b> : Defective <b>Y</b> : Crack, Gap</p>
<p><b>Remarks</b> (R) Front Seat - Grime - Medium / (L) Front Trim - Grime - Small</p>	<p><b>Remarks</b> (R) Front Door - Repair Traces - Yes / (R) Front Fender - Repair Traces - Yes / Bonnet - Repair Traces - Yes / (L) Front Fender - Repair Traces - Yes / (L) Rear Fender - Repair Traces - Yes / Trunk Hood, Rear Gate - Repair Traces - Yes / (R) Rear Fender - Repair Traces - Yes / (R) Rear Door - Repair Traces - Yes / Roof - Repair Traces - Yes / (R) Front Fender, Molding - Scratch - Minimal / (R) Mirror - Scratch - Minimal / (R) Front Door, Molding - Scratch - Medium / (R) Rear Door, Molding - Scratch - Minimal / (R) Rear Fender, Molding - Scratch - Medium / Rear Bumper, Lamps, Panels - Scratch - Small / Trunk Hood, Rear Gate - Scratch - Medium / (L) Rear Fender, Molding - Scratch - Small / Overall Exterior - Full Re-Paint in same color - Yes / (L) Rear Door, Molding - Scratch - Small / (L) Front Door, Molding - Scratch - Small / Front Windshield - Scratch, Stone chip - Small / Roof - Scratch - Minimal / (L) Front Fender, Molding - Repair mark - Yes / (L) Front Fender, Molding - Scratch &amp; Dent - Small / Front Bumper, Grille, Lamps - Crack, Gap - Large / Bonnet, Headlight - Scratch - Minimal</p>
