## General Information

Date & Time: 26, Jan, 2026 10:58

<b>Make</b>	Toyota	<b>Model</b>	Vios
<b>YOM</b>	2024	<b>Odo Meter Reading</b>	71,206
<b>Registration No.</b>	NHN6739	<b>Chassis No.</b>	PA1B18F37R4250156
<b>CC</b>	1.3	<b>Transmission</b>	CVT
<b>Fuel Type</b>	Gas	<b>Type of Body</b>	Sedan
<b>Colour</b>	Silver

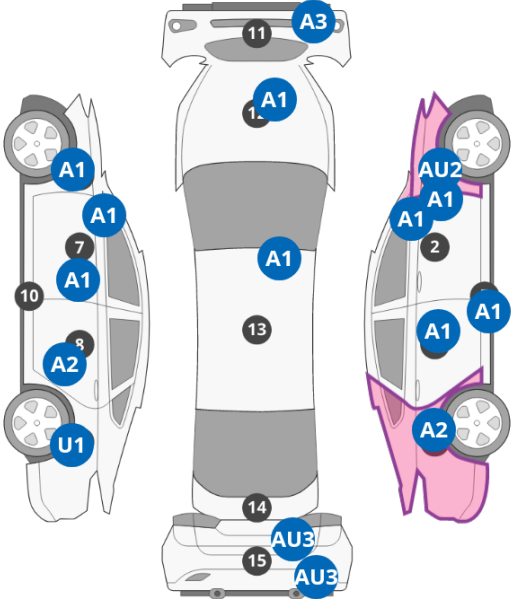
<p><b>A</b> : Scratch <b>AU</b> : Scratch &amp; Dent <b>B</b> : Modified <b>C</b> : Corrosion <b>G</b> : Stone chip <b>P</b> : Faded <b>S</b> : Rust <b>SC</b> : Rust &amp; Corrosion <b>U</b> : Dent <b>X</b> : Defective <b>Y</b> : Crack, Gap</p>
<p><b>Remarks</b> (L) Front Floor Mat - Missing - Yes / (R) Front Floor Mat - Grime - Large / (R) Front Trim - Grime - Minimal / (R) Front Seat - Grime - Small / Rear Seat - Grime - Small / (L) Front Trim - Grime - Small</p>	<p><b>Remarks</b> (R) Front Fender - Repair Traces - Yes / (R) Rear Fender - Repair Traces - Yes / (R) Rear Door - Repair Traces - Yes / (R) Front Fender, Molding - Scratch &amp; Dent - Small / (R) Mirror - Scratch - Minimal / (R) Front Door, Molding - Scratch - Minimal / (R) Rear Door, Molding - Scratch - Minimal / (R) Step, In-panel, Side Spoiler - Scratch - Minimal / (R) Rear Fender, Molding - Scratch - Small / (R) Rear Fender, Molding - Repair mark - Yes / Trunk Hood, Rear Gate - Scratch &amp; Dent - Medium / Rear Bumper, Lamps, Panels - Scratch &amp; Dent - Medium / (L) Rear Fender, Molding - Dent - Minimal / (L) Rear Door, Molding - Scratch - Small / (L) Front Door, Molding - Scratch - Minimal / Roof - Scratch - Minimal / (R) Front Fender, Molding - Repair mark - Yes / (L) Mirror - Scratch - Minimal / (L) Front Fender, Molding - Scratch - Minimal / Bonnet, Headlight - Scratch - Minimal / Front Bumper, Grille, Lamps - Scratch - Medium</p>
