## General Information

<b>Make</b>	Toyota	<b>Model</b>	Vios
<b>YOM</b>	2024	<b>Odo Meter Reading</b>	18,193
<b>Registration No.</b>	DBM5915	<b>Chassis No.</b>	PA1B18F34R4243228
<b>CC</b>	1.3	<b>Transmission</b>	CVT
<b>Fuel Type</b>	Gas	<b>Type of Body</b>	Sedan
<b>Colour</b>	Black

## Body / Panel Condition

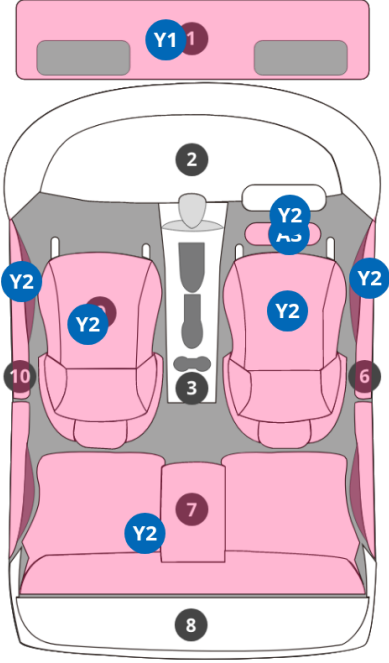
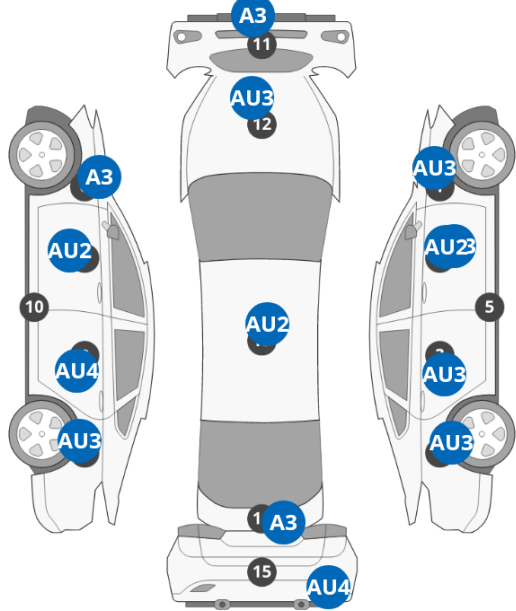
<b>Interior Evaluation :</b>	B	<b>Exterior Evaluation :</b>	E

<p><b>a</b> : Cut, Fray <b>d</b> : Loose, Deformed <b>k</b> : Animal Hair <b>s</b> : Smell <b>t</b> : Cigarette Burns <b>x</b> : Defective <b>y</b> : Stain</p>		<p><b>A</b> : Scratch <b>AU</b> : Scratch &amp; Dent <b>B</b> : Modified <b>C</b> : Corrosion <b>G</b> : Stone chip <b>P</b> : Faded <b>S</b> : Rust <b>SC</b> : Rust &amp; Corrosion <b>U</b> : Dent <b>X</b> : Defective <b>Y</b> : Crack, Gap</p>	
<p><b>Remarks</b> (L) Front Floor Mat - Cut, Crack - Medium / (R) Front Floor Mat - Grime - Small / (L) Front Trim - Grime - Small / (R) Front Trim - Grime - Small / (L) Front Seat - Grime - Small / (R) Front Seat - Grime - Small / Rear Seat - Grime - Small / Ceiling - Grime - Minimal</p>		<p><b>Remarks</b> (R) Front Fender - Repair Traces - Yes / (L) Front Fender - Repair Traces - Yes / Front Bumper, Grille, Lamps - Scratch - Medium / Bonnet, Headlight - Scratch &amp; Dent - Medium / (L) Front Fender, Molding - Scratch - Medium / (L) Front Door, Molding - Scratch &amp; Dent - Small / (L) Rear Door, Molding - Scratch &amp; Dent - Large / (L) Rear Fender, Molding - Scratch &amp; Dent - Medium / Rear Bumper, Lamps, Panels - Scratch &amp; Dent - Large / (R) Rear Fender, Molding - Scratch &amp; Dent - Medium / (R) Rear Door, Molding - Scratch &amp; Dent - Medium / (R) Step, In-panel, Side Spoiler - Scratch &amp; Dent - Medium / (R) Front Fender, Molding - Scratch &amp; Dent - Medium / (R) Front Door, Molding - Scratch &amp; Dent - Small / Roof - Scratch &amp; Dent - Small / Trunk Hood, Rear Gate - Scratch - Medium</p>
