Make	Toyota	Model	Vios
YOM	2024	Odo Meter Reading	48,899
Registration No.	DBO9103	Chassis No.	PA1B18F39R4258385
CC	1.3	Transmission	CVT
Fuel Type	Gas	Type of Body	Sedan
Colour	Black

Body / Panel Condition

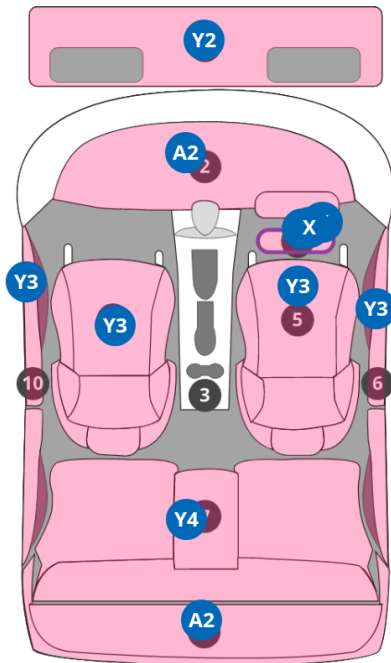
Interior Evaluation : C	Exterior Evaluation : E

<p>a : Cut, Fray d : Loose, Deformed k : Animal Hair s : Smell t : Cigarette Burns x : Defective y : Stain</p>

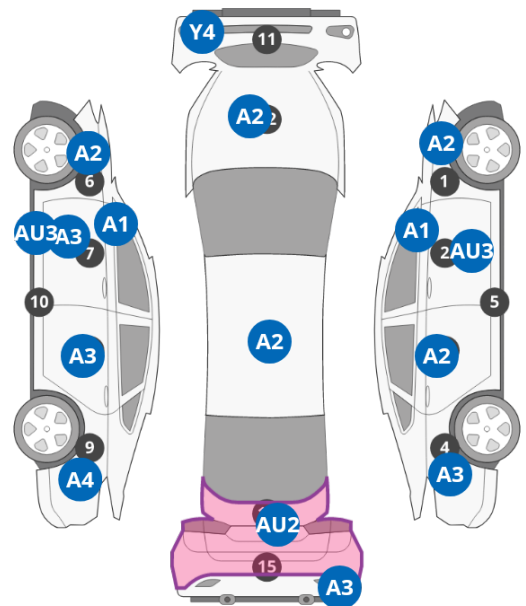
<p>A : Scratch AU : Scratch & Dent B : Modified C : Corrosion G : Stone chip P : Faded S : Rust SC : Rust & Corrosion U : Dent X : Defective Y : Crack, Gap</p>
Remarks (R) Front Seat - Grime - Medium / (R) Front Trim - Grime - Medium / Rear Seat - Grime - Large / Trunk Room - Worn, Scratch, Cut, Crack - Small / (L) Front Trim - Grime - Medium / (L) Front Seat - Grime - Medium / (R) Front Floor Mat - Missing - Yes / (L) Front Floor Mat - Missing - Yes / Mat Other - Missing - Yes / Ceiling - Grime - Small / Dashboard - Worn, Scratch, Cut, Crack - Small	Remarks Trunk Hood, Rear Gate - Repair Traces - Yes / Front Bumper, Grille, Lamps - Crack, Gap - Large / Trunk Hood, Rear Gate - Repair mark - Yes / (L) Mirror - Scratch - Minimal / (L) Front Fender, Molding - Scratch - Small / (L) Front Door, Molding - Scratch - Medium / (L) Step, In-panel, Side Spoiler - Scratch & Dent - Medium / (L) Rear Door, Molding - Scratch - Medium / (L) Rear Fender, Molding - Scratch - Large / Trunk Hood, Rear Gate - Scratch & Dent - Small / Rear Bumper, Lamps, Panels - Scratch - Medium / (R) Rear Fender, Molding - Scratch - Medium / (R) Rear Door, Molding - Scratch - Small / (R) Front Door, Molding - Scratch & Dent - Medium / (R) Mirror - Scratch - Minimal / (R) Front Fender, Molding - Scratch - Small / Roof - Scratch - Small / Bonnet, Headlight - Scratch - Small
