## General Information

<b>Make</b>	Toyota	<b>Model</b>	Vios
<b>YOM</b>	2023	<b>Odo Meter Reading</b>	27,032
<b>Registration No.</b>	NFP7530	<b>Chassis No.</b>	PA1B18F34N4192646
<b>CC</b>	1.3	<b>Transmission</b>	CVT
<b>Fuel Type</b>	Gas	<b>Type of Body</b>	Sedan
<b>Colour</b>	Red Mica Metallic

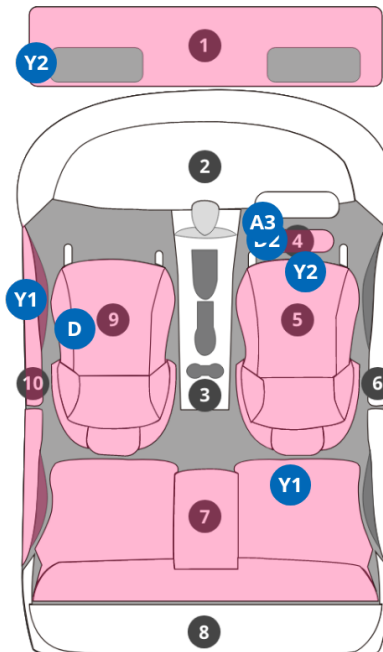
<p><b>a</b> : Cut, Fray <b>d</b> : Loose, Deformed <b>k</b> : Animal Hair <b>s</b> : Smell <b>t</b> : Cigarette Burns <b>x</b> : Defective <b>y</b> : Stain</p>

<p><b>A</b> : Scratch <b>AU</b> : Scratch &amp; Dent <b>B</b> : Modified <b>C</b> : Corrosion <b>G</b> : Stone chip <b>P</b> : Faded <b>S</b> : Rust <b>SC</b> : Rust &amp; Corrosion <b>U</b> : Dent <b>X</b> : Defective <b>Y</b> : Crack, Gap</p>
<p><b>Remarks</b> (L) Front Floor Mat - Worked - Small / (L) Front Seat - Worn - Yes / (R) Front Seat - Grime - Small / (L) Front Trim - Grime - Minimal / Ceiling - Grime - Small / Rear Seat - Grime - Minimal / (L) Front Floor Mat - Cut, Crack - Medium</p>	<p><b>Remarks</b> (R) Front Fender - Repair Traces - Yes / (L) Front Fender - Repair Traces - Yes / Trunk Hood, Rear Gate - Repair Traces - Yes / Front Bumper, Grille, Lamps - Scratch &amp; Dent - Large / (R) Front Fender, Molding - Scratch &amp; Dent - Large / (R) Front Door, Molding - Scratch &amp; Dent - Large / (R) Step, In-panel, Side Spoiler - Dent - Minimal / (R) Mirror - Scratch - Minimal / (R) Rear Door, Molding - Scratch - Small / (R) Rear Fender, Molding - Scratch - Medium / Rear Bumper, Lamps, Panels - Repair mark - Yes / Rear Bumper, Lamps, Panels - Scratch - Small / (L) Rear Fender, Molding - Scratch - Small / Trunk Hood, Rear Gate - Scratch - Small / (L) Rear Door, Molding - Scratch - Minimal / (L) Front Door, Molding - Scratch - Minimal / (L) Mirror - Scratch - Minimal / (L) Front Fender, Molding - Scratch - Small / Bonnet, Headlight - Scratch - Minimal / Roof - Scratch &amp; Dent - Small</p>
