General Information

| Make | Toyota | Model | Vios |
| Registration No. | NFR7022 | Chassis No. | PA1B18F30R4256011 |

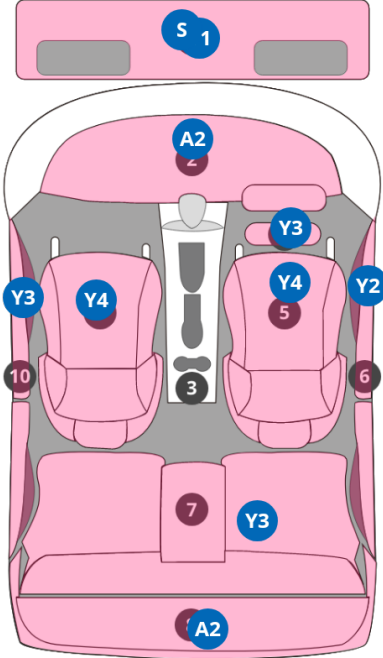
| Interior Evaluation : D | Exterior Evaluation : C |
| <p>Remarks Rear Seat - Grime - Medium / (R) Front Trim - Grime - Small / (R) Front Seat - Grime - Large / Trunk Room - Worn, Scratch, Cut, Crack - Small / (L) Front Trim - Grime - Medium / (L) Front Seat - Grime - Large / (L) Front Floor Mat - Grime - Medium / Ceiling - Grime - Minimal / Overall Interior - Smell - Yes / Dashboard - Worn, Scratch, Cut, Crack - Small</p> | <p>Remarks (L) Front Fender, Molding - Dent - Small / Bonnet, Headlight - Scratch & Dent - Small / (L) Front Door, Molding - Scratch - Minimal / (L) Rear Fender, Molding - Scratch - Minimal / (L) Rear Door, Molding - Scratch - Minimal / Trunk Hood, Rear Gate - Scratch & Dent - Minimal / Rear Bumper, Lamps, Panels - Scratch & Dent - Large / (R) Rear Fender, Molding - Scratch - Small / Roof - Scratch - Small / (R) Rear Door, Molding - Scratch - Minimal / (R) Front Door, Molding - Scratch - Large / (R) Front Fender, Molding - Scratch - Minimal / Front Bumper, Grille, Lamps - Scratch - Small</p> |
