## General Information

<b>Make</b>	Toyota	<b>Model</b>	Vios
<b>YOM</b>	2024	<b>Odo Meter Reading</b>	17,644
<b>Registration No.</b>	NFR9344	<b>Chassis No.</b>	PA1B18F30R4258051
<b>CC</b>	1.3	<b>Transmission</b>	CVT
<b>Fuel Type</b>	Gas	<b>Type of Body</b>	Sedan
<b>Colour</b>	Black

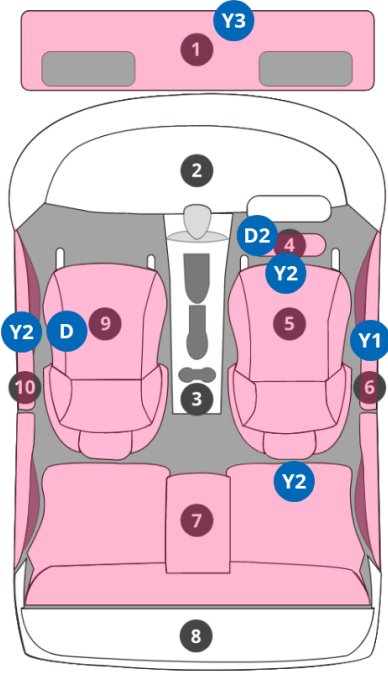
<b>Interior Evaluation :</b> <span style="float: right; color: red; font-weight: bold;">B</span>	<b>Exterior Evaluation :</b> <span style="float: right; color: red; font-weight: bold;">D</span>

<p><b>A</b> : Scratch <b>AU</b> : Scratch &amp; Dent <b>B</b> : Modified <b>C</b> : Corrosion <b>G</b> : Stone chip <b>P</b> : Faded <b>S</b> : Rust <b>SC</b> : Rust &amp; Corrosion <b>U</b> : Dent <b>X</b> : Defective <b>Y</b> : Crack, Gap</p>
<p><b>Remarks</b> (L) Front Seat - Worn - Yes / (R) Front Seat - Grime - Small / (R) Front Trim - Grime - Minimal / (L) Front Trim - Grime - Small / Ceiling - Grime - Medium / Rear Seat - Grime - Small / (L) Front Floor Mat - Worked - Small</p>	<p><b>Remarks</b> (R) Front Fender, Molding - Scratch - Small / (R) Mirror - Scratch - Small / (R) Step, In-panel, Side Spoiler - Scratch &amp; Dent - Minimal / (R) Front Door, Molding - Scratch - Small / (R) Rear Door, Molding - Scratch - Small / (R) Rear Fender, Molding - Scratch - Small / Rear Bumper, Lamps, Panels - Scratch - Small / Trunk Hood, Rear Gate - Scratch - Minimal / (L) Rear Fender, Molding - Scratch - Small / (L) Rear Door, Molding - Scratch - Small / (L) Step, In-panel, Side Spoiler - Scratch &amp; Dent - Medium / (L) Front Door, Molding - Scratch - Small / (L) Mirror - Scratch - Minimal / (L) Front Fender, Molding - Scratch - Minimal / Front Bumper, Grille, Lamps - Scratch - Medium / Bonnet, Headlight - Scratch - Small / Roof - Scratch - Minimal</p>
