## General Information

<b>Make</b>	Toyota	<b>Model</b>	Vios
<b>YOM</b>	2024	<b>Odo Meter Reading</b>	21,842
<b>Registration No.</b>	NFR9697	<b>Chassis No.</b>	PA1B18F39R4242088
<b>CC</b>	1.3	<b>Transmission</b>	M/T
<b>Fuel Type</b>	Gas	<b>Type of Body</b>	Sedan
<b>Colour</b>	White

## Body / Panel Condition

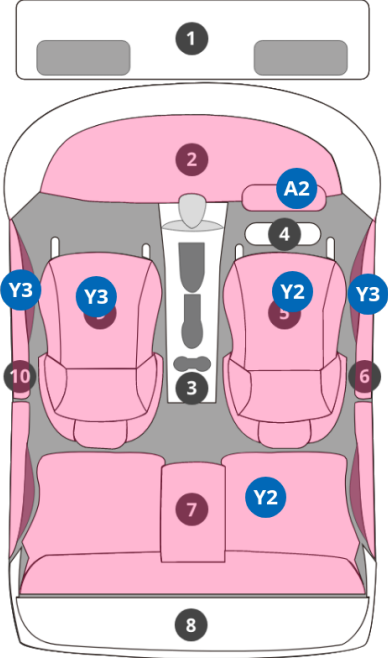
<b>Interior Evaluation :</b> <span style="float: right;"><b>B</b></span>	<b>Exterior Evaluation :</b> <span style="float: right;"><b>D</b></span>

<p><b>a</b> : Cut, Fray <b>d</b> : Loose, Deformed <b>k</b> : Animal Hair <b>s</b> : Smell <b>t</b> : Cigarette Burns <b>x</b> : Defective <b>y</b> : Stain</p>

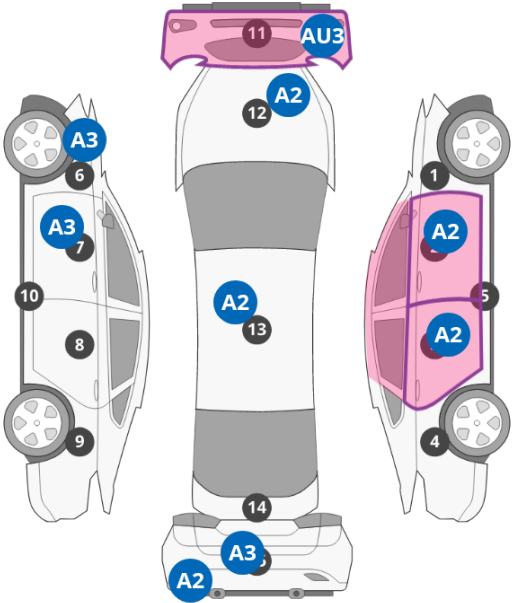
<p><b>A</b> : Scratch <b>AU</b> : Scratch &amp; Dent <b>B</b> : Modified <b>C</b> : Corrosion <b>G</b> : Stone chip <b>P</b> : Faded <b>S</b> : Rust <b>SC</b> : Rust &amp; Corrosion <b>U</b> : Dent <b>X</b> : Defective <b>Y</b> : Crack, Gap</p>
<p><b>Remarks</b> (R) Front Seat - Grime - Small / (R) Front Trim - Grime - Medium / Rear Seat - Grime - Small / (L) Front Trim - Grime - Medium / (L) Front Seat - Grime - Medium / Steering Wheel - Worn, Peel, Crack - Small</p>	<p><b>Remarks</b> (R) Front Door - Repair Traces - Yes / (R) Rear Door - Repair Traces - Yes / (R) Front Door, Molding - Repair mark - Yes / (R) Rear Door, Molding - Repair mark - Yes / Roof - Scratch - Small / (L) Front Door, Molding - Scratch - Medium / Trunk Hood, Rear Gate - Scratch - Medium / Rear Bumper, Lamps, Panels - Scratch - Small / (R) Rear Door, Molding - Scratch - Small / (R) Front Door, Molding - Scratch - Small / Bonnet, Headlight - Scratch - Small / (L) Front Fender, Molding - Scratch - Medium / Front Bumper, Grille, Lamps - Scratch &amp; Dent - Medium / Front Bumper, Grille, Lamps - Repair mark - Yes</p>
