## General Information

<b>Make</b>	Toyota	<b>Model</b>	Vios
<b>YOM</b>	2024	<b>Odo Meter Reading</b>	55,471
<b>Registration No.</b>	NHM6795	<b>Chassis No.</b>	PA1B18F3XR4240172
<b>CC</b>	1.3	<b>Transmission</b>	CVT
<b>Fuel Type</b>	Gas	<b>Type of Body</b>	Sedan
<b>Colour</b>	Red

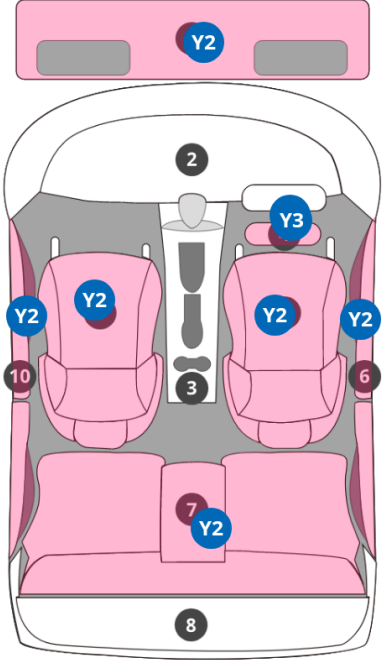
<b>Interior Evaluation :</b> <span style="float: right;"><b>C</b></span>	<b>Exterior Evaluation :</b> <span style="float: right;"><b>E</b></span>

<p><b>a</b> : Cut, Fray <b>d</b> : Loose, Deformed <b>k</b> : Animal Hair <b>s</b> : Smell <b>t</b> : Cigarette Burns <b>x</b> : Defective <b>y</b> : Stain</p>

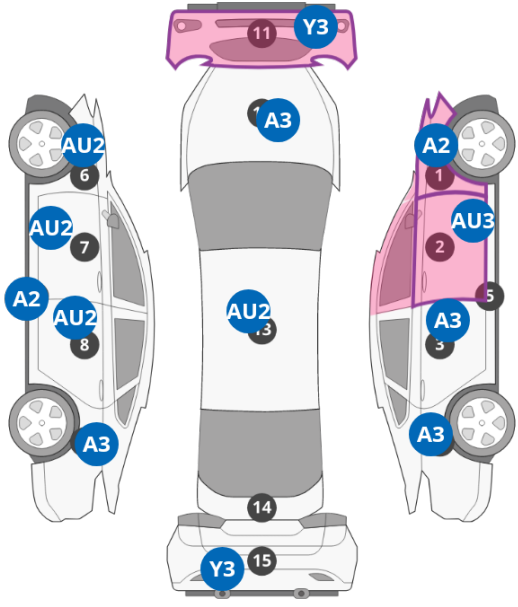
<p><b>A</b> : Scratch <b>AU</b> : Scratch &amp; Dent <b>B</b> : Modified <b>C</b> : Corrosion <b>G</b> : Stone chip <b>P</b> : Faded <b>S</b> : Rust <b>SC</b> : Rust &amp; Corrosion <b>U</b> : Dent <b>X</b> : Defective <b>Y</b> : Crack, Gap</p>
<p><b>Remarks</b> (L) Front Floor Mat - Cut, Crack - Medium / (R) Front Floor Mat - Grime - Medium / (L) Front Seat - Grime - Small / (R) Front Seat - Grime - Small / Rear Seat - Grime - Small / (L) Front Trim - Grime - Small / (R) Front Trim - Grime - Small / Ceiling - Grime - Small</p>	<p><b>Remarks</b> (R) Front Fender - Repair Traces - Yes / (R) Rear Fender - Repair Traces - Yes / (L) Front Door, Molding - Scratch &amp; Dent - Small / (L) Rear Door, Molding - Scratch &amp; Dent - Small / Roof - Scratch &amp; Dent - Small / (L) Front Fender, Molding - Scratch &amp; Dent - Small / Bonnet, Headlight - Scratch - Medium / Front Bumper, Grille, Lamps - Repair mark - Yes / Front Bumper, Grille, Lamps - Crack, Gap - Medium / (R) Front Fender, Molding - Repair mark - Yes / (R) Front Fender, Molding - Scratch - Small / (R) Front Door, Molding - Scratch &amp; Dent - Medium / (R) Front Door, Molding - Repair mark - Yes / (R) Rear Door, Molding - Scratch - Medium / (R) Rear Fender, Molding - Scratch - Medium / Rear Bumper, Lamps, Panels - Crack, Gap - Medium / (L) Rear Fender, Molding - Scratch - Medium / Trunk Hood, Rear Gate - Scratch &amp; Dent - Small / (L) Step, In-panel, Side Spoiler - Scratch - Small</p>
