## General Information

<b>Make</b>	Toyota	<b>Model</b>	Vios
<b>YOM</b>	2025	<b>Odo Meter Reading</b>	47,626
<b>Registration No.</b>	DBP7097	<b>Chassis No.</b>	PA1B18F33R4263678
<b>CC</b>	1.3	<b>Transmission</b>	CVT
<b>Fuel Type</b>	Gas	<b>Type of Body</b>	Sedan
<b>Colour</b>	Black

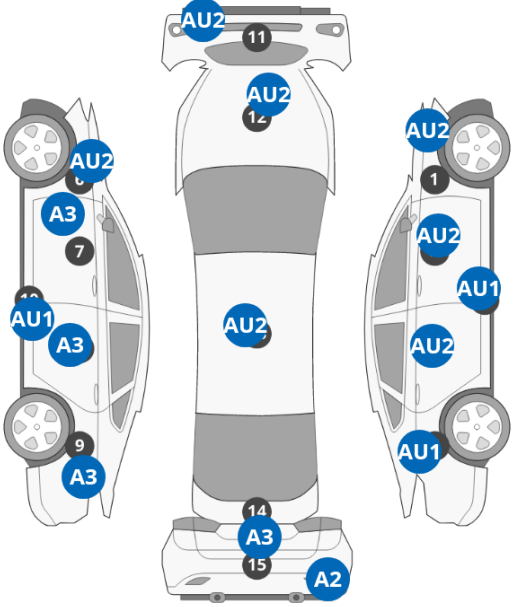
<p><b>A</b> : Scratch <b>AU</b> : Scratch &amp; Dent <b>B</b> : Modified <b>C</b> : Corrosion <b>G</b> : Stone chip <b>P</b> : Faded <b>S</b> : Rust <b>SC</b> : Rust &amp; Corrosion <b>U</b> : Dent <b>X</b> : Defective <b>Y</b> : Crack, Gap</p>
<p><b>Remarks</b> (L) Front Floor Mat - Cut, Crack - Medium / (R) Front Floor Mat - Grime - Medium / (L) Front Seat - Grime - Small / (R) Front Seat - Grime - Small / Rear Seat - Grime - Minimal / (L) Front Trim - Grime - Small / (R) Front Trim - Grime - Small</p>	<p><b>Remarks</b> (L) Rear Door, Molding - Scratch - Medium / Roof - Scratch &amp; Dent - Small / (L) Front Door, Molding - Scratch - Medium / (L) Front Fender, Molding - Scratch &amp; Dent - Small / Bonnet, Headlight - Scratch &amp; Dent - Small / Front Bumper, Grille, Lamps - Scratch &amp; Dent - Small / (L) Rear Fender, Molding - Scratch - Medium / Trunk Hood, Rear Gate - Scratch - Medium / Rear Bumper, Lamps, Panels - Scratch - Small / (R) Rear Fender, Molding - Scratch &amp; Dent - Minimal / (R) Rear Door, Molding - Scratch &amp; Dent - Small / (R) Front Door, Molding - Scratch &amp; Dent - Small / (R) Step, In-panel, Side Spoiler - Scratch &amp; Dent - Minimal / (R) Front Fender, Molding - Scratch &amp; Dent - Small / (L) Step, In-panel, Side Spoiler - Scratch &amp; Dent - Minimal</p>
