## General Information

Date & Time: 10, Feb, 2026 08:36

<b>Make</b>	Toyota	<b>Model</b>	Vios
<b>YOM</b>	2025	<b>Odo Meter Reading</b>	25,948
<b>Registration No.</b>	DBP9516	<b>Chassis No.</b>	PA1B18F35R4266386
<b>CC</b>	1.3	<b>Transmission</b>	CVT
<b>Fuel Type</b>	Gas	<b>Type of Body</b>	Sedan
<b>Colour</b>	Silver

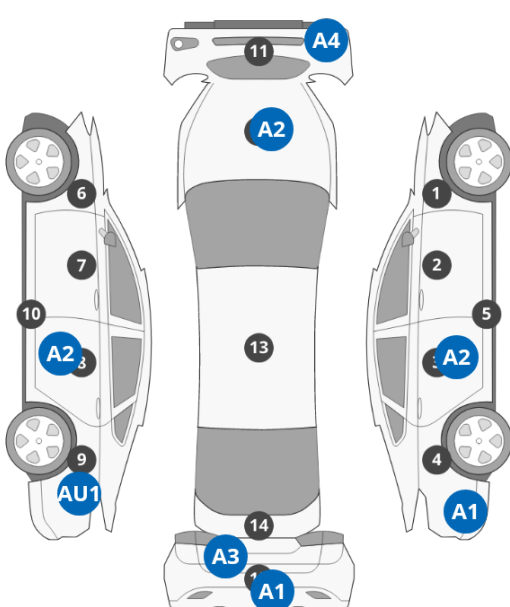
<p><b>A</b> : Scratch <b>AU</b> : Scratch &amp; Dent <b>B</b> : Modified <b>C</b> : Corrosion <b>G</b> : Stone chip <b>P</b> : Faded <b>S</b> : Rust <b>SC</b> : Rust &amp; Corrosion <b>U</b> : Dent <b>X</b> : Defective <b>Y</b> : Crack, Gap</p>
<b>Remarks</b> (R) Front Seat - Grime - Large / Dashboard - Worn, Scratch, Cut, Crack - Medium / (R) Front Trim - Grime - Large / Rear Seat - Grime - Large / (R) Rear Trim - Grime - Small / Trunk Room - Worn, Scratch, Cut, Crack - Small / (L) Rear Trim - Grime - Small / (L) Front Trim - Grime - Medium / (L) Front Seat - Grime - Medium / (L) Front Floor Mat - Grime - Medium / Ceiling - Grime - Small / Console, Switches, Vents - Worn, Scratch, Cut, Crack - Medium	<b>Remarks</b> Front Bumper, Grille, Lamps - Scratch - Large / Bonnet, Headlight - Scratch - Small / (R) Rear Door, Molding - Scratch - Small / (R) Rear Fender, Molding - Scratch - Minimal / Trunk Hood, Rear Gate - Scratch - Medium / Rear Bumper, Lamps, Panels - Scratch - Minimal / (L) Rear Fender, Molding - Scratch & Dent - Minimal / (L) Rear Door, Molding - Scratch - Small
