## General Information

<b>Make</b>	Toyota	<b>Model</b>	Vios
<b>YOM</b>	2025	<b>Odo Meter Reading</b>	14,826
<b>Registration No.</b>	DBQ6231	<b>Chassis No.</b>	PA1B18F36R4270222
<b>CC</b>	1.3	<b>Transmission</b>	CVT
<b>Fuel Type</b>	Gas	<b>Type of Body</b>	Sedan
<b>Colour</b>	Red Mica Metallic

## Body / Panel Condition

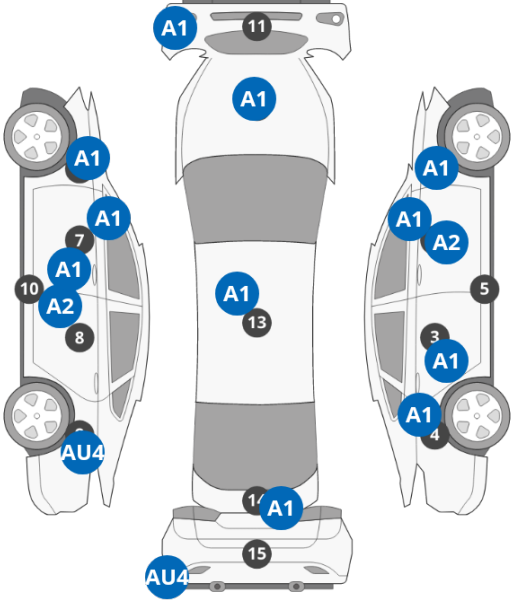
<p><b>A</b> : Scratch <b>AU</b> : Scratch &amp; Dent <b>B</b> : Modified <b>C</b> : Corrosion <b>G</b> : Stone chip <b>P</b> : Faded <b>S</b> : Rust <b>SC</b> : Rust &amp; Corrosion <b>U</b> : Dent <b>X</b> : Defective <b>Y</b> : Crack, Gap</p>
<p><b>Remarks</b> (L) Front Seat - Worn - Yes / (R) Front Seat - Grime - Small / Rear Seat - Grime - Small / (R) Front Trim - Grime - Minimal / (L) Front Trim - Grime - Minimal / (L) Front Floor Mat - Worked - Small / Ceiling - Grime - Minimal</p>	<p><b>Remarks</b> (R) Front Fender, Molding - Scratch - Minimal / (R) Mirror - Scratch - Minimal / (R) Front Door, Molding - Scratch - Small / (R) Rear Door, Molding - Scratch - Minimal / (R) Rear Fender, Molding - Scratch - Minimal / Rear Bumper, Lamps, Panels - Scratch &amp; Dent - Large / (L) Rear Fender, Molding - Scratch &amp; Dent - Large / Trunk Hood, Rear Gate - Scratch - Minimal / (L) Rear Door, Molding - Scratch - Small / (L) Front Door, Molding - Scratch - Minimal / (L) Mirror - Scratch - Minimal / (L) Front Fender, Molding - Scratch - Minimal / Front Bumper, Grille, Lamps - Scratch - Minimal / Bonnet, Headlight - Scratch - Minimal / Roof - Scratch - Minimal</p>
