## General Information

| <b>Make</b> | Toyota | <b>Model</b> | Hiace |
| <b>YOM</b> | 2025 | <b>Odo Meter Reading</b> | 14,441 |
| <b>Registration No.</b> | DBR4246 | <b>Chassis No.</b> | JTFJT02P0R5038339 |

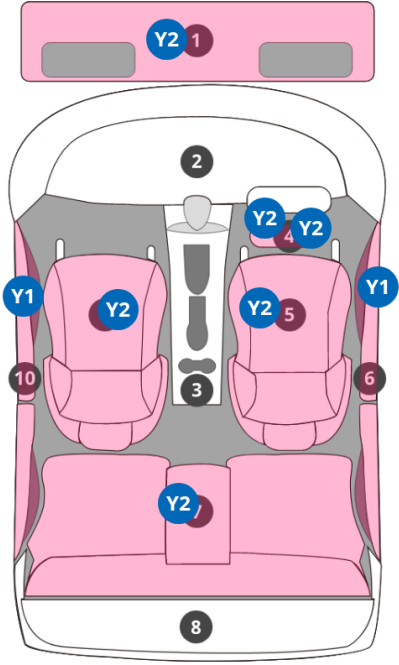
| <b>Remarks</b><br>(L) Front Floor Mat - Grime - Small / (R) Front Floor Mat - Grime - Small / (L) Front Seat - Grime - Small / (R) Front Seat - Grime - Small / Rear Seat - Grime - Small / Ceiling - Grime - Small / (L) Front Trim - Grime - Minimal / (R) Front Trim - Grime - Minimal | <b>Remarks</b><br>Roof - Repair Traces - Yes / (L) Front Door, Molding - Scratch & Dent - Minimal / (L) Front Fender, Molding - Scratch - Small / Front Panel - Scratch & Dent - Small / Front Bumper, Grille, Lamps - Scratch - Small / (R) Front Fender, Molding - Scratch & Dent - Minimal / (R) Front Door, Molding - Scratch & Dent - Small / (R) Center Panel - Scratch & Dent - Minimal / (L) Center Panel - Scratch & Dent - Minimal / Roof - Scratch & Dent - Small / (R) Rear Fender, Molding - Scratch & Dent - Small / (R) Rear Door, Molding - Scratch & Dent - Small / Trunk Hood, Rear Gate - Scratch & Dent - Medium / Rear Bumper, Lamps, Panels - Scratch & Dent - Small / (L) Rear Fender, Molding - Scratch & Dent - Small / (L) Rear Door, Molding - Scratch & Dent - Small / (L) Step, In-panel, Side Spoiler - Scratch & Dent - Small / (R) Step, In-panel, Side Spoiler - Scratch & Dent - Minimal |
