## General Information

<b>Make</b>	Toyota	<b>Model</b>	Hilux
<b>YOM</b>	2025	<b>Odo Meter Reading</b>	52,487
<b>Registration No.</b>	DBR5060	<b>Chassis No.</b>	MR0AB8DD3R5154519
<b>CC</b>	2.4	<b>Transmission</b>	A/T
<b>Fuel Type</b>	Diesel	<b>Type of Body</b>	Pickup
<b>Colour</b>	Red

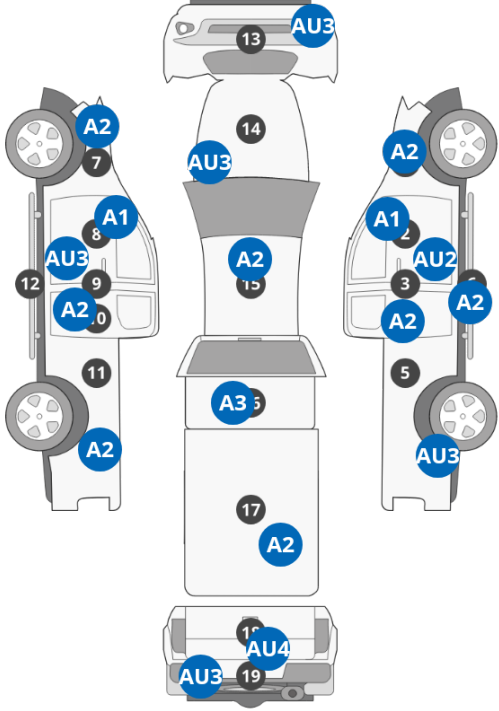
<p><b>A</b> : Scratch <b>AU</b> : Scratch &amp; Dent <b>B</b> : Modified <b>C</b> : Corrosion <b>G</b> : Stone chip <b>P</b> : Faded <b>S</b> : Rust <b>SC</b> : Rust &amp; Corrosion <b>U</b> : Dent <b>X</b> : Defective <b>Y</b> : Crack, Gap</p>
<p><b>Remarks</b> (R) Front Seat - Grime - Minimal / (R) Front Floor Mat - Grime - Medium / (L) Front Floor Mat - Missing - Yes / Mat Other - Grime - Small / Ceiling - Grime - Small / Sunvisor, Sunglass Holder - Cut, Crack - Small</p>	<p><b>Remarks</b> (R) Front Fender, Molding - Scratch - Small / (R) Front Door, Molding - Scratch &amp; Dent - Small / (R) Rear Door, Molding - Scratch - Small / (R) Step, In-panel, Side Spoiler - Scratch - Small / (R) Side Gate - Scratch &amp; Dent - Medium / Rear Bumper, Lamps, Panels - Scratch &amp; Dent - Medium / Rear Gate - Scratch &amp; Dent - Large / (L) Side Gate - Scratch - Small / (L) Rear Door, Molding - Scratch - Small / (L) Front Door, Molding - Scratch &amp; Dent - Medium / (L) Mirror - Scratch - Minimal / (L) Front Fender, Molding - Scratch - Small / Front Bumper, Grille, Lamps - Scratch &amp; Dent - Medium / Roof - Scratch - Small / Cab Back Panel - Scratch - Medium / Cargo Bed Floor - Scratch - Small / Bonnet, Headlight - Scratch &amp; Dent - Medium / (R) Mirror - Scratch - Minimal</p>
