## General Information

<b>Make</b>	Toyota	<b>Model</b>	Vios
<b>YOM</b>	2025	<b>Odo Meter Reading</b>	13,371
<b>Registration No.</b>	DBR9730	<b>Chassis No.</b>	PA1B18F34R4277590
<b>CC</b>	1.3	<b>Transmission</b>	CVT
<b>Fuel Type</b>	Gas	<b>Type of Body</b>	Sedan
<b>Colour</b>	Red Mica Metallic

## Body / Panel Condition

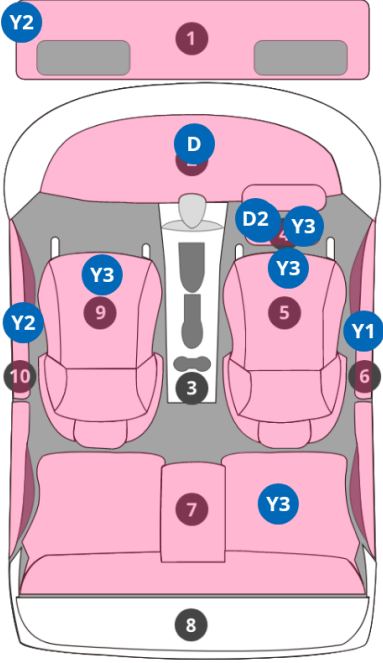
<b>Interior Evaluation :</b> <span style="float: right; color: red; font-weight: bold;">C</span>	<b>Exterior Evaluation :</b> <span style="float: right; color: red; font-weight: bold;">C</span>

<p><b>A</b> : Scratch <b>AU</b> : Scratch &amp; Dent <b>B</b> : Modified <b>C</b> : Corrosion <b>G</b> : Stone chip <b>P</b> : Faded <b>S</b> : Rust <b>SC</b> : Rust &amp; Corrosion <b>U</b> : Dent <b>X</b> : Defective <b>Y</b> : Crack, Gap</p>
<p><b>Remarks</b> (R) Front Seat - Grime - Medium / (L) Front Seat - Grime - Medium / (L) Front Floor Mat - Cut, Crack - Small / (L) Front Floor Mat - Worked - Small / (R) Front Trim - Grime - Minimal / (L) Front Trim - Grime - Small / Rear Seat - Grime - Medium / (R) Front Floor Mat - Grime - Medium / Ceiling - Grime - Small / Dashboard - Traces of Adhesive Tape - Yes</p>	<p><b>Remarks</b> (R) Front Fender, Molding - Scratch - Minimal / (R) Mirror - Scratch - Minimal / (R) Front Door, Molding - Scratch - Minimal / (R) Rear Door, Molding - Scratch - Minimal / (R) Rear Fender, Molding - Scratch - Small / Trunk Hood, Rear Gate - Scratch - Small / (L) Rear Fender, Molding - Scratch - Minimal / (L) Rear Door, Molding - Scratch - Small / (L) Front Door, Molding - Scratch - Small / Rear Bumper, Lamps, Panels - Scratch &amp; Dent - Small / (L) Mirror - Scratch - Minimal / (L) Front Fender, Molding - Scratch - Minimal / Front Bumper, Grille, Lamps - Scratch &amp; Dent - Medium / Bonnet, Headlight - Scratch - Small / Roof - Scratch - Minimal</p>

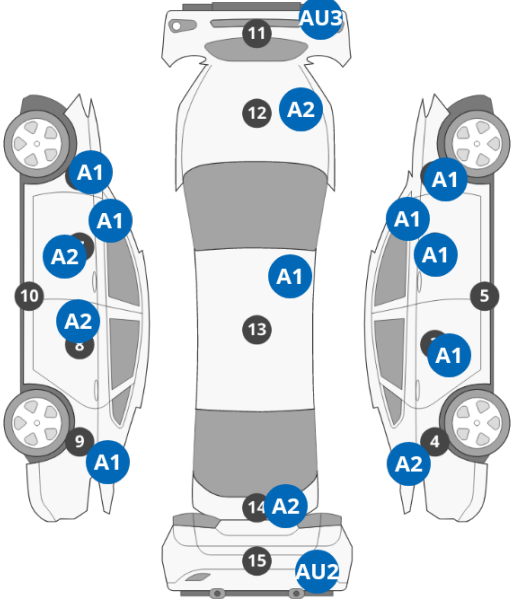
<p><b>Inspector Notes</b></p>
<p>no warranty booklet, with jack, no tools, with spare tire, with LTO plate, scratches on tail light</p>
