## General Information

<b>Make</b>	Toyota	<b>Model</b>	Wigo
<b>YOM</b>	2025	<b>Odo Meter Reading</b>	23,892
<b>Registration No.</b>	DBS4665	<b>Chassis No.</b>	MHKAA1BC1RJ030717
<b>CC</b>	1.0	<b>Transmission</b>	CVT
<b>Fuel Type</b>	Gas	<b>Type of Body</b>	Hatchback
<b>Colour</b>	Silver

## Body / Panel Condition

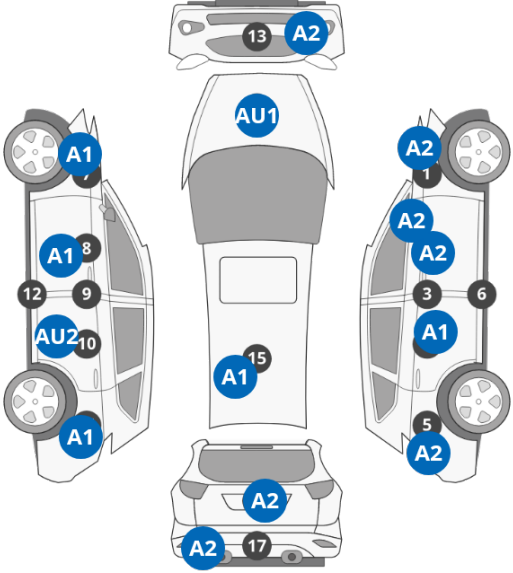
<p><b>A</b> : Scratch <b>AU</b> : Scratch &amp; Dent <b>B</b> : Modified <b>C</b> : Corrosion <b>G</b> : Stone chip <b>P</b> : Faded <b>S</b> : Rust <b>SC</b> : Rust &amp; Corrosion <b>U</b> : Dent <b>X</b> : Defective <b>Y</b> : Crack, Gap</p>
<p><b>Remarks</b> (R) Front Seat - Grime - Large / Rear Seat - Grime - Medium / (L) Front Seat - Grime - Medium / Ceiling - Grime - Small</p>	<p><b>Remarks</b> (L) Rear Door, Molding - Scratch &amp; Dent - Small / (L) Rear Fender, Molding - Scratch - Minimal / Rear Bumper, Lamps, Panels - Scratch - Small / Trunk Hood, Rear Gate - Scratch - Small / (R) Rear Fender, Molding - Scratch - Small / (R) Rear Door, Molding - Scratch - Minimal / (R) Front Door, Molding - Scratch - Small / (R) Mirror - Scratch - Small / (R) Front Fender, Molding - Scratch - Small / Front Bumper, Grille, Lamps - Scratch - Small / Bonnet, Headlight - Scratch &amp; Dent - Minimal / (L) Front Fender, Molding - Scratch - Minimal / (L) Front Door, Molding - Scratch - Minimal / Roof - Scratch - Minimal</p>
