## General Information

<b>Make</b>	Toyota	<b>Model</b>	Vios
<b>YOM</b>	2025	<b>Odo Meter Reading</b>	11,532
<b>Registration No.</b>	VAB7046	<b>Chassis No.</b>	PA1B18F39R4273972
<b>CC</b>	1.3	<b>Transmission</b>	CVT
<b>Fuel Type</b>	Gas	<b>Type of Body</b>	Sedan
<b>Colour</b>	Silver

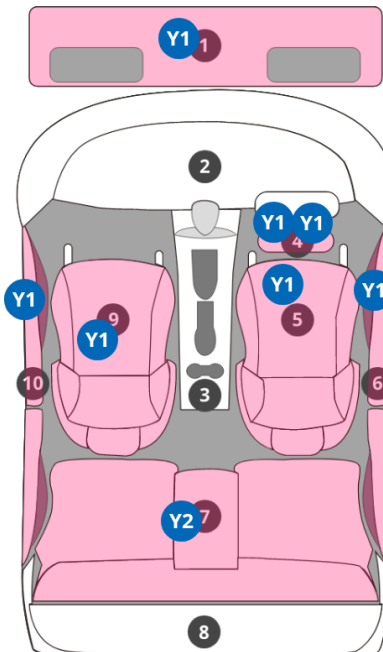
<b>Interior Evaluation :</b> <span style="float: right; color: red; font-weight: bold;">A</span>	<b>Exterior Evaluation :</b> <span style="float: right; color: red; font-weight: bold;">D</span>

<p><b>a</b> : Cut, Fray <b>d</b> : Loose, Deformed <b>k</b> : Animal Hair <b>s</b> : Smell <b>t</b> : Cigarette Burns <b>x</b> : Defective <b>y</b> : Stain</p>

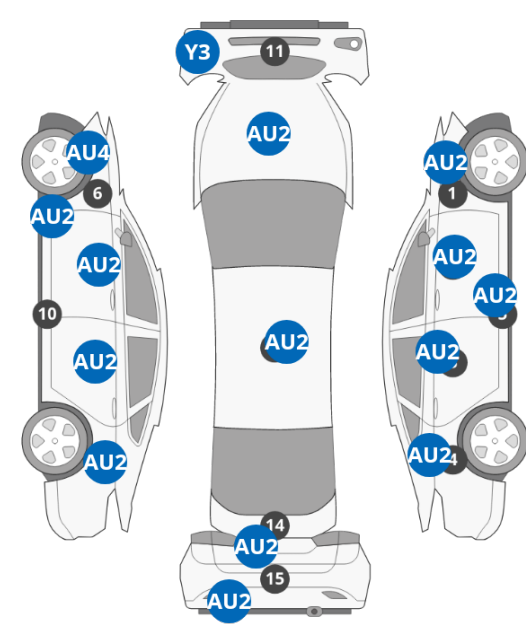
<p><b>A</b> : Scratch <b>AU</b> : Scratch &amp; Dent <b>B</b> : Modified <b>C</b> : Corrosion <b>G</b> : Stone chip <b>P</b> : Faded <b>S</b> : Rust <b>SC</b> : Rust &amp; Corrosion <b>U</b> : Dent <b>X</b> : Defective <b>Y</b> : Crack, Gap</p>
<p><b>Remarks</b> (R) Front Seat - Grime - Minimal / (L) Front Seat - Grime - Minimal / (L) Front Floor Mat - Grime - Minimal / (R) Front Floor Mat - Grime - Minimal / Rear Seat - Grime - Small / Ceiling - Grime - Minimal / (L) Front Trim - Grime - Minimal / (R) Front Trim - Grime - Minimal</p>	<p><b>Remarks</b> (R) Rear Fender, Molding - Scratch &amp; Dent - Small / (R) Rear Door, Molding - Scratch &amp; Dent - Small / (R) Front Door, Molding - Scratch &amp; Dent - Small / (R) Step, In-panel, Side Spoiler - Scratch &amp; Dent - Small / (R) Front Fender, Molding - Scratch &amp; Dent - Small / Front Bumper, Grille, Lamps - Crack, Gap - Medium / (L) Front Fender, Molding - Scratch &amp; Dent - Large / (L) Front Door, Molding - Scratch &amp; Dent - Small / (L) Step, In-panel, Side Spoiler - Scratch &amp; Dent - Small / (L) Rear Door, Molding - Scratch &amp; Dent - Small / Roof - Scratch &amp; Dent - Small / (L) Rear Fender, Molding - Scratch &amp; Dent - Small / Trunk Hood, Rear Gate - Scratch &amp; Dent - Small / Rear Bumper, Lamps, Panels - Scratch &amp; Dent - Small / Bonnet, Headlight - Scratch &amp; Dent - Small</p>
