Date & Time: 11, Feb, 2026 07:43

Make	Toyota	Model	Vios
YOM	2025	Odo Meter Reading	2,978
Registration No.	VAB7768	Chassis No.	PA1B18F3XR4261961
CC	1.3	Transmission	CVT
Fuel Type	Gas	Type of Body	Sedan
Colour	Silver

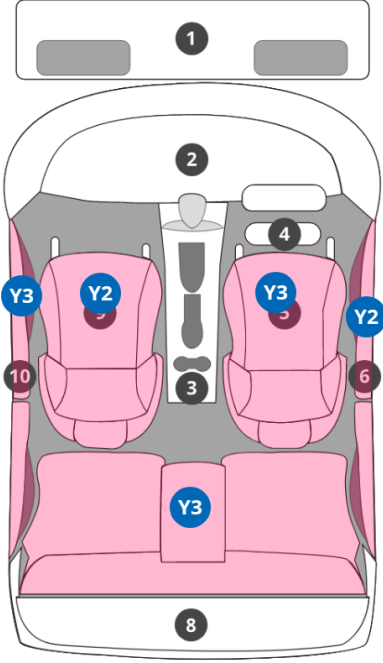
<b>Interior Evaluation :</b> <span style="float: right;"><b>B</b></span>	<b>Exterior Evaluation :</b> <span style="float: right;"><b>C</b></span>

<p><b>A</b> : Scratch <b>AU</b> : Scratch &amp; Dent <b>B</b> : Modified <b>C</b> : Corrosion <b>G</b> : Stone chip <b>P</b> : Faded <b>S</b> : Rust <b>SC</b> : Rust &amp; Corrosion <b>U</b> : Dent <b>X</b> : Defective <b>Y</b> : Crack, Gap</p>
<p><b>Remarks</b> (R) Front Seat - Grime - Medium / (R) Front Trim - Grime - Small / Rear Seat - Grime - Medium / (L) Front Trim - Grime - Medium / (L) Front Seat - Grime - Small</p>	<p><b>Remarks</b> (R) Front Door, Molding - Scratch &amp; Dent - Small / Roof - Scratch - Medium / (L) Rear Fender, Molding - Scratch - Minimal / (L) Rear Door, Molding - Scratch - Small / (L) Front Fender, Molding - Scratch - Minimal / Bonnet, Headlight - Scratch - Medium / (R) Front Fender, Molding - Scratch - Minimal / (R) Rear Door, Molding - Scratch - Minimal / (R) Rear Fender, Molding - Scratch - Medium / Trunk Hood, Rear Gate - Scratch - Minimal / Rear Bumper, Lamps, Panels - Scratch - Minimal / Front Bumper, Grille, Lamps - Scratch - Minimal</p>
