## General Information

<b>Make</b>	Toyota	<b>Model</b>	Vios
<b>YOM</b>	2024	<b>Odo Meter Reading</b>	8,373
<b>Registration No.</b>	DBO8548	<b>Chassis No.</b>	PA1B18F36R4256997
<b>CC</b>	1.3	<b>Transmission</b>	CVT
<b>Fuel Type</b>	Gas	<b>Type of Body</b>	Sedan
<b>Colour</b>	Red Mica Metallic

## Body / Panel Condition

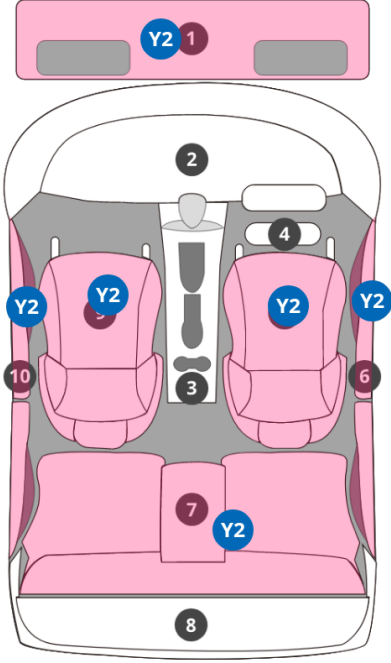
<p><b>A</b> : Scratch <b>AU</b> : Scratch &amp; Dent <b>B</b> : Modified <b>C</b> : Corrosion <b>G</b> : Stone chip <b>P</b> : Faded <b>S</b> : Rust <b>SC</b> : Rust &amp; Corrosion <b>U</b> : Dent <b>X</b> : Defective <b>Y</b> : Crack, Gap</p>
<p><b>Remarks</b> (L) Front Seat - Grime - Small / (R) Front Seat - Grime - Small / Rear Seat - Grime - Small / (L) Front Trim - Grime - Small / (R) Front Trim - Grime - Small / Ceiling - Grime - Small</p>	<p><b>Remarks</b> Trunk Hood, Rear Gate - Repair Traces - Yes / Roof - Scratch &amp; Dent - Small / (L) Rear Door, Molding - Scratch &amp; Dent - Medium / (L) Rear Fender, Molding - Scratch &amp; Dent - Medium / Trunk Hood, Rear Gate - Repair mark - Yes / Rear Bumper, Lamps, Panels - Scratch - Large / (R) Rear Fender, Molding - Scratch - Medium / (R) Rear Door, Molding - Scratch &amp; Dent - Small / (R) Step, In-panel, Side Spoiler - Scratch &amp; Dent - Small / (R) Front Door, Molding - Scratch &amp; Dent - Small / (R) Front Fender, Molding - Scratch &amp; Dent - Small / Front Bumper, Grille, Lamps - Scratch - Medium / Bonnet, Headlight - Scratch &amp; Dent - Small / (L) Front Fender, Molding - Scratch &amp; Dent - Small / (L) Front Door, Molding - Scratch - Medium / (L) Step, In-panel, Side Spoiler - Scratch &amp; Dent - Small</p>
