## General Information

<b>Make</b>	Toyota	<b>Model</b>	Vios
<b>YOM</b>	2025	<b>Odo Meter Reading</b>	23,082
<b>Registration No.</b>	DBP7445	<b>Chassis No.</b>	PA1B18F36R4265389
<b>CC</b>	1.3	<b>Transmission</b>	CVT
<b>Fuel Type</b>	Gas	<b>Type of Body</b>	Sedan
<b>Colour</b>	Black

## Body / Panel Condition

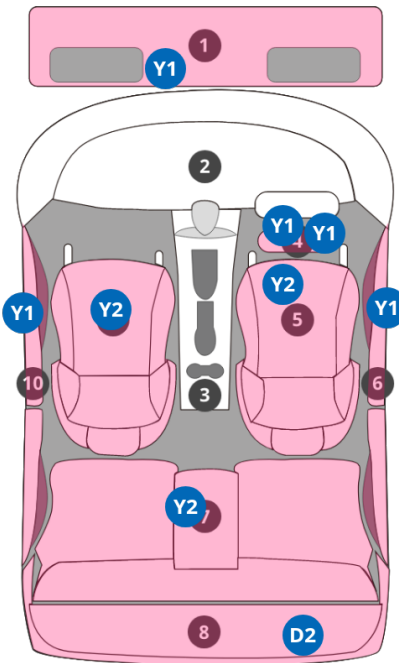
<p><b>A</b> : Scratch <b>AU</b> : Scratch &amp; Dent <b>B</b> : Modified <b>C</b> : Corrosion <b>G</b> : Stone chip <b>P</b> : Faded <b>S</b> : Rust <b>SC</b> : Rust &amp; Corrosion <b>U</b> : Dent <b>X</b> : Defective <b>Y</b> : Crack, Gap</p>
<p><b>Remarks</b> (L) Front Seat - Grime - Small / (R) Front Seat - Grime - Small / (L) Front Trim - Grime - Minimal / (R) Front Trim - Grime - Minimal / Rear Seat - Grime - Small / Ceiling - Grime - Minimal / (L) Front Floor Mat - Grime - Minimal / (R) Front Floor Mat - Grime - Minimal / Trunk Room - Loose, Deformed - Small</p>	<p><b>Remarks</b> (L) Rear Door - Repair Traces - Yes / (L) Front Door, Molding - Scratch &amp; Dent - Small / (L) Rear Door, Molding - Partially Missing - Yes / (L) Rear Door, Molding - Scratch &amp; Dent - Large / (L) Rear Fender, Molding - Scratch &amp; Dent - Large / Trunk Hood, Rear Gate - Scratch &amp; Dent - Minimal / Rear Bumper, Lamps, Panels - Scratch - Small / (R) Rear Fender, Molding - Scratch &amp; Dent - Small / (R) Rear Door, Molding - Scratch - Medium / (R) Front Door, Molding - Scratch &amp; Dent - Medium / (R) Step, In-panel, Side Spoiler - Scratch &amp; Dent - Small / (R) Front Fender, Molding - Scratch - Medium / Front Bumper, Grille, Lamps - Scratch &amp; Dent - Small / (L) Front Fender, Molding - Scratch &amp; Dent - Small / Bonnet, Headlight - Scratch &amp; Dent - Small / Roof - Scratch - Small</p>
