## General Information

<b>Make</b>	Toyota	<b>Model</b>	Wigo
<b>YOM</b>	2025	<b>Odo Meter Reading</b>	14,058
<b>Registration No.</b>	DBR4510	<b>Chassis No.</b>	MHKAA1BC6RJ028803
<b>CC</b>	1.0	<b>Transmission</b>	CVT
<b>Fuel Type</b>	Gas	<b>Type of Body</b>	Hatchback
<b>Colour</b>	Red

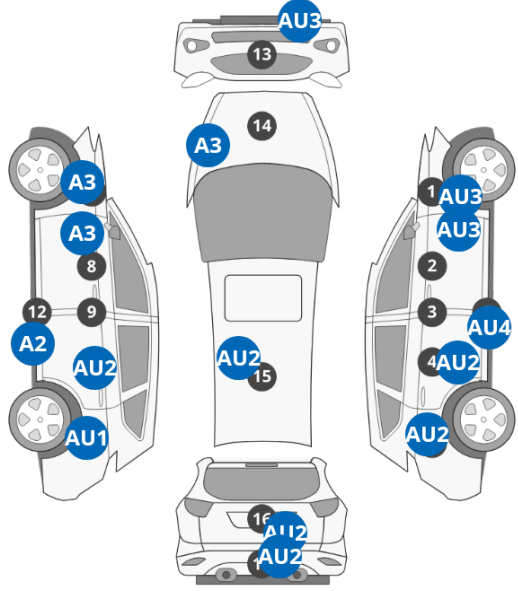
<p><b>A</b> : Scratch <b>AU</b> : Scratch &amp; Dent <b>B</b> : Modified <b>C</b> : Corrosion <b>G</b> : Stone chip <b>P</b> : Faded <b>S</b> : Rust <b>SC</b> : Rust &amp; Corrosion <b>U</b> : Dent <b>X</b> : Defective <b>Y</b> : Crack, Gap</p>
<b>Remarks</b> (L) Front Floor Mat - Grime - Medium / Mat Other - Grime - Small / (R) Front Floor Mat - Grime - Small / (L) Front Seat - Grime - Small / (R) Front Seat - Grime - Minimal / Rear Seat - Grime - Small / (L) Front Trim - Grime - Small / (R) Front Trim - Grime - Small	<b>Remarks</b> Roof - Scratch & Dent - Small / (L) Front Fender, Molding - Scratch - Medium / Bonnet, Headlight - Scratch - Medium / Front Bumper, Grille, Lamps - Scratch & Dent - Medium / (R) Front Fender, Molding - Scratch & Dent - Medium / (R) Front Door, Molding - Scratch & Dent - Medium / (R) Rear Fender, Molding - Scratch & Dent - Small / (R) Rear Door, Molding - Scratch & Dent - Small / (R) Step, In-panel, Side Spoiler - Scratch & Dent - Large / Trunk Hood, Rear Gate - Scratch & Dent - Small / (L) Rear Fender, Molding - Scratch & Dent - Minimal / Rear Bumper, Lamps, Panels - Scratch & Dent - Small / (L) Rear Door, Molding - Scratch & Dent - Small / (L) Front Door, Molding - Scratch - Medium / (L) Step, In-panel, Side Spoiler - Scratch - Small
