## General Information

Date & Time: 06, Feb, 2026 12:44

<b>Make</b>	Toyota	<b>Model</b>	Yaris Cross
<b>YOM</b>	2024	<b>Odo Meter Reading</b>	21,747
<b>Registration No.</b>	NOW6706	<b>Chassis No.</b>	MHFAB8BF5R0016677
<b>CC</b>	1.5	<b>Transmission</b>	CVT
<b>Fuel Type</b>	Hybrid	<b>Type of Body</b>	SUV
<b>Colour</b>	Black

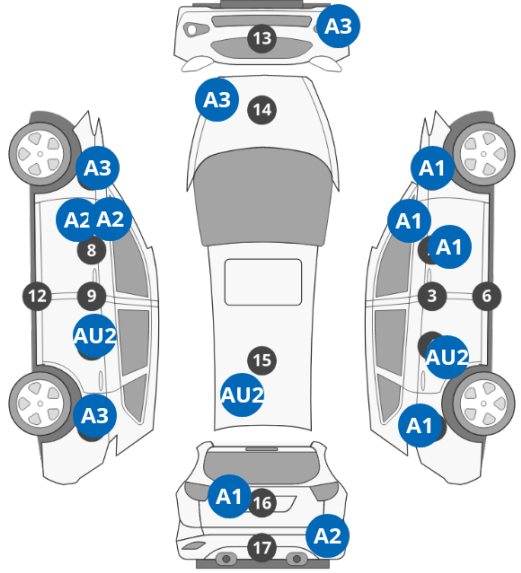
<p><b>A</b> : Scratch <b>AU</b> : Scratch &amp; Dent <b>B</b> : Modified <b>C</b> : Corrosion <b>G</b> : Stone chip <b>P</b> : Faded <b>S</b> : Rust <b>SC</b> : Rust &amp; Corrosion <b>U</b> : Dent <b>X</b> : Defective <b>Y</b> : Crack, Gap</p>
<p><b>Remarks</b> (L) Front Floor Mat - Missing - Yes / (R) Front Floor Mat - Missing - Yes / Mat Other - Missing - Yes / (L) Front Seat - Worn - Yes / Sunvisor, Sunglass Holder - Grime - Medium / Rear Seat - Grime - Small / (R) Front Seat - Grime - Medium</p>	<p><b>Remarks</b> (R) Mirror - Scratch - Minimal / (R) Front Fender, Molding - Scratch - Minimal / (R) Rear Door, Molding - Scratch &amp; Dent - Small / (R) Front Door, Molding - Scratch - Minimal / (R) Rear Fender, Molding - Scratch - Minimal / Rear Bumper, Lamps, Panels - Scratch - Small / Trunk Hood, Rear Gate - Scratch - Minimal / (L) Rear Fender, Molding - Scratch - Medium / (L) Rear Door, Molding - Scratch &amp; Dent - Small / (L) Front Door, Molding - Scratch - Small / (L) Front Fender, Molding - Scratch - Medium / Front Bumper, Grille, Lamps - Scratch - Medium / Bonnet, Headlight - Scratch - Medium / (L) Mirror - Scratch - Small / Roof - Scratch &amp; Dent - Small</p>
