## General Information

| <b>Make</b> | Toyota | <b>Model</b> | Veloz |
| <b>Registration No.</b> | DBB5826 | <b>Chassis No.</b> | MHFAB1BY4P3047004 |

## Body / Panel Condition

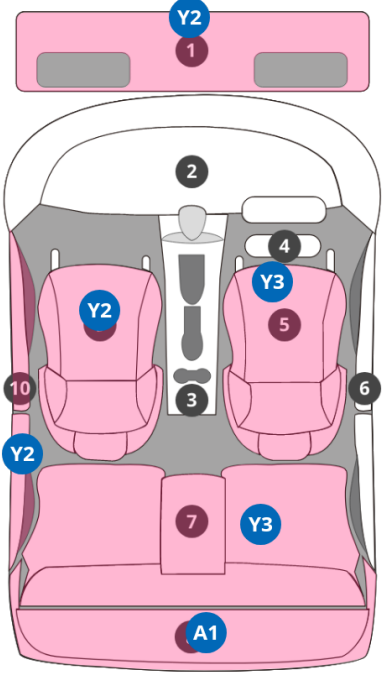
| <p><b>Remarks</b><br/>(R) Front Seat - Grime - Medium / Rear Seat - Grime - Medium / Trunk Room - Worn, Scratch, Cut, Crack - Minimal / (L) Rear Trim - Grime - Small / (L) Front Seat - Grime - Small / Ceiling - Grime - Small</p> | <p><b>Remarks</b><br/>(L) Mirror - Scratch - Minimal / (L) Rear Door, Molding - Scratch - Minimal / (L) Rear Fender, Molding - Scratch - Minimal / Rear Bumper, Lamps, Panels - Scratch - Minimal / (R) Front Door, Molding - Scratch - Minimal / Front Bumper, Grille, Lamps - Scratch - Small / (R) Rear Fender, Molding - Scratch - Minimal / Roof - Scratch - Minimal</p> |
