## General Information

<b>Make</b>	Toyota	<b>Model</b>	Vios
<b>YOM</b>	2024	<b>Odo Meter Reading</b>	9,474
<b>Registration No.</b>	DBF6766	<b>Chassis No.</b>	PA1B18F38R4248917
<b>CC</b>	1.3	<b>Transmission</b>	CVT
<b>Fuel Type</b>	Gas	<b>Type of Body</b>	Sedan
<b>Colour</b>	Red Mica Metallic

## Body / Panel Condition

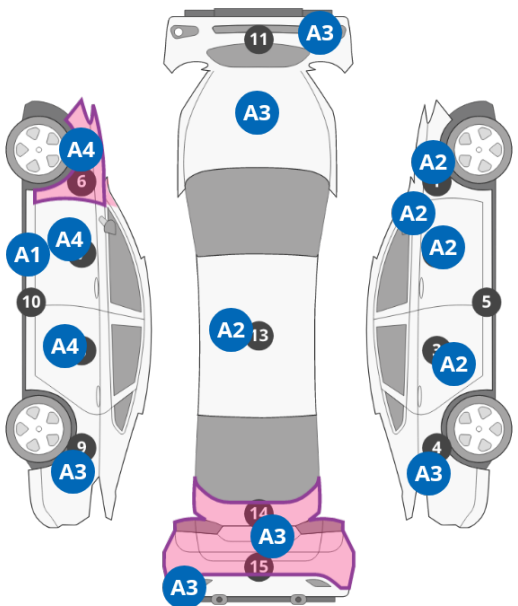
<p><b>A</b> : Scratch <b>AU</b> : Scratch &amp; Dent <b>B</b> : Modified <b>C</b> : Corrosion <b>G</b> : Stone chip <b>P</b> : Faded <b>S</b> : Rust <b>SC</b> : Rust &amp; Corrosion <b>U</b> : Dent <b>X</b> : Defective <b>Y</b> : Crack, Gap</p>
<p><b>Remarks</b> (R) Front Seat - Grime - Medium / (R) Front Trim - Grime - Small / Rear Seat - Grime - Small / (L) Front Trim - Grime - Medium / (L) Front Floor Mat - Grime - Medium / (L) Front Seat - Grime - Minimal / Ceiling - Grime - Minimal / Dashboard - Traces of Adhesive Tape - Yes</p>	<p><b>Remarks</b> (L) Front Fender - Repair Traces - Yes / (L) Front Door - Repair Traces - Yes / Trunk Hood, Rear Gate - Repair Traces - Yes / (R) Rear Door - Repair Traces - Yes / Roof - Repair Traces - Yes / Roof - Scratch - Small / (L) Rear Fender, Molding - Scratch - Medium / (L) Rear Door, Molding - Scratch - Large / (L) Front Door, Molding - Scratch - Large / (L) Front Fender, Molding - Scratch - Large / (L) Step, In-panel, Side Spoiler - Scratch - Minimal / Bonnet, Headlight - Scratch - Medium / Front Bumper, Grille, Lamps - Scratch - Medium / (R) Front Fender, Molding - Scratch - Small / (R) Mirror - Scratch - Small / (R) Front Door, Molding - Scratch - Small / (R) Rear Door, Molding - Scratch - Small / (R) Rear Fender, Molding - Scratch - Medium / Trunk Hood, Rear Gate - Scratch - Medium / Rear Bumper, Lamps, Panels - Scratch - Medium / Trunk Hood, Rear Gate - Repair mark - Yes / (L) Front Fender, Molding - Repair mark - Yes</p>
