General Information

Make	Toyota	Model	Vios
YOM	2023	Odo Meter Reading	55,543
Registration No.	DBI3066	Chassis No.	PA1B18F33P4217880
CC	1.3	Transmission	CVT
Fuel Type	Gas	Type of Body	Sedan
Colour	Red

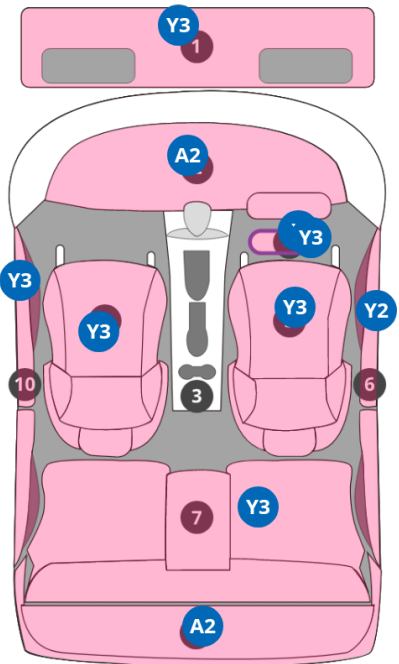
Interior Evaluation : C	Exterior Evaluation : E

<p>a : Cut, Fray d : Loose, Deformed k : Animal Hair s : Smell t : Cigarette Burns x : Defective y : Stain</p>

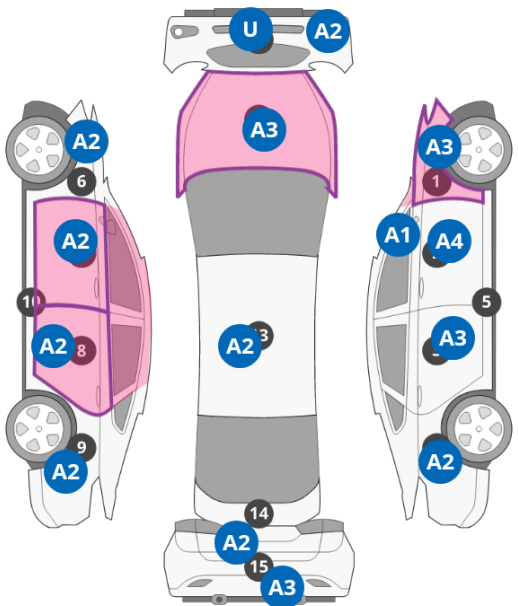
<p>A : Scratch AU : Scratch & Dent B : Modified C : Corrosion G : Stone chip P : Faded S : Rust SC : Rust & Corrosion U : Dent X : Defective Y : Crack, Gap</p>
<p>Remarks (R) Front Seat - Grime - Medium / (R) Front Trim - Grime - Small / Rear Seat - Grime - Medium / Trunk Room - Worn, Scratch, Cut, Crack - Small / (L) Front Trim - Grime - Medium / (L) Front Seat - Grime - Medium / (R) Front Floor Mat - Missing - Yes / (L) Front Floor Mat - Grime - Medium / Ceiling - Grime - Medium / Dashboard - Worn, Scratch, Cut, Crack - Small</p>	<p>Remarks (R) Front Door - Repair Traces - Yes / (R) Front Fender - Repair Traces - Yes / Bonnet - Repair Traces - Yes / (L) Front Fender - Repair Traces - Yes / (L) Front Door - Repair Traces - Yes / (L) Rear Door - Repair Traces - Yes / (L) Rear Fender - Repair Traces - Yes / Trunk Hood, Rear Gate - Repair Traces - Yes / (R) Rear Fender - Repair Traces - Yes / (R) Rear Door - Repair Traces - Yes / Roof - Repair Traces - Yes / (L) Rear Door, Molding - Repair mark - Yes / (L) Front Door, Molding - Repair mark - Yes / Bonnet, Headlight - Repair mark - Yes / (R) Front Fender, Molding - Repair mark - Yes / (L) Front Fender, Molding - Scratch - Small / (L) Front Door, Molding - Scratch - Small / (L) Rear Door, Molding - Scratch - Small / (L) Rear Fender, Molding - Scratch - Small / Bonnet, Headlight - Scratch - Medium / Front Bumper, Grille, Lamps - Scratch - Small / (R) Front Fender, Molding - Scratch - Medium / (R) Mirror - Scratch - Minimal / (R) Front Door, Molding - Scratch - Large / (R) Rear Door, Molding - Scratch - Medium / (R) Rear Fender, Molding - Scratch - Small / Trunk Hood, Rear Gate - Scratch - Small / Rear Bumper, Lamps, Panels - Scratch - Medium / Roof - Scratch - Small / Member (Bolted) - Dent - Yes</p>
