## General Information

<b>Make</b>	Toyota	<b>Model</b>	Vios
<b>YOM</b>	2025	<b>Odo Meter Reading</b>	4,692
<b>Registration No.</b>	DBU7874	<b>Chassis No.</b>	PA1B18F39S4290521
<b>CC</b>	1.3	<b>Transmission</b>	CVT
<b>Fuel Type</b>	Gas	<b>Type of Body</b>	Sedan
<b>Colour</b>	Silver

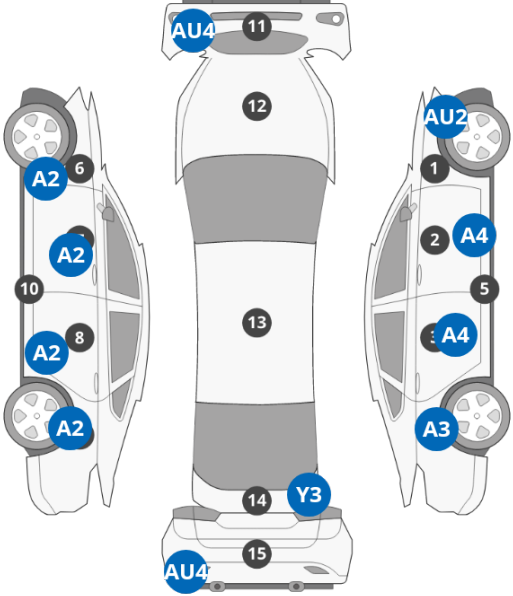
<p><b>A</b> : Scratch <b>AU</b> : Scratch &amp; Dent <b>B</b> : Modified <b>C</b> : Corrosion <b>G</b> : Stone chip <b>P</b> : Faded <b>S</b> : Rust <b>SC</b> : Rust &amp; Corrosion <b>U</b> : Dent <b>X</b> : Defective <b>Y</b> : Crack, Gap</p>
<p><b>Remarks</b> Rear Seat - Grime - Large / (R) Front Seat - Grime - Large / (L) Front Floor Mat - Worked - Large</p>	<p><b>Remarks</b> Front Bumper, Grille, Lamps - Scratch &amp; Dent - Large / (L) Front Fender, Molding - Scratch - Small / (L) Front Door, Molding - Scratch - Small / (L) Rear Door, Molding - Scratch - Small / (L) Rear Fender, Molding - Scratch - Small / Rear Bumper, Lamps, Panels - Scratch &amp; Dent - Large / Trunk Hood, Rear Gate - Crack, Gap - Medium / (R) Rear Fender, Molding - Scratch - Medium / (R) Rear Door, Molding - Scratch - Large / (R) Front Door, Molding - Scratch - Large / (R) Front Fender, Molding - Scratch &amp; Dent - Small</p>
