## General Information

<b>Make</b>	Toyota	<b>Model</b>	Hilux Tamaraw
<b>YOM</b>	2025	<b>Odo Meter Reading</b>	4,145
<b>Registration No.</b>	GBK4605	<b>Chassis No.</b>	PAHACACA6S6426142
<b>CC</b>	2.4	<b>Transmission</b>	M/T
<b>Fuel Type</b>	Diesel	<b>Type of Body</b>	Pickup
<b>Colour</b>	White

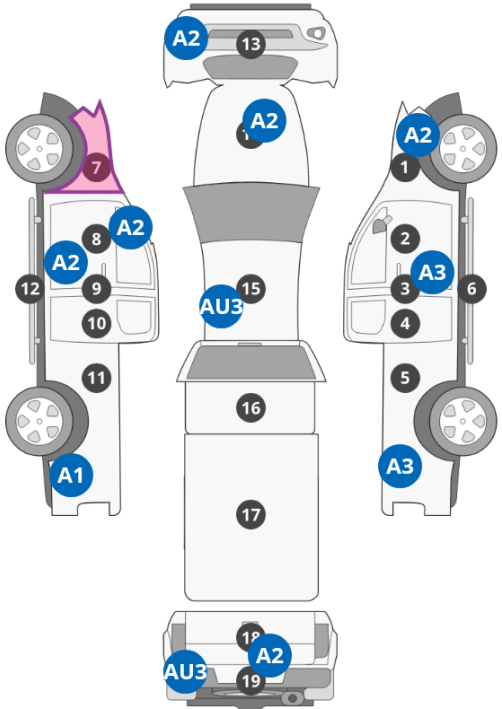
<p><b>A</b> : Scratch <b>AU</b> : Scratch &amp; Dent <b>B</b> : Modified <b>C</b> : Corrosion <b>G</b> : Stone chip <b>P</b> : Faded <b>S</b> : Rust <b>SC</b> : Rust &amp; Corrosion <b>U</b> : Dent <b>X</b> : Defective <b>Y</b> : Crack, Gap</p>
<p><b>Remarks</b> (L) Front Floor Mat - Worked - Small / Ceiling - Grime - Small / (R) Front Floor Mat - Grime - Small</p>	<p><b>Remarks</b> (L) Front Door, Molding - Scratch - Small / (L) Mirror - Scratch - Small / Roof - Scratch &amp; Dent - Medium / (L) Side Gate - Scratch - Minimal / Rear Bumper, Lamps, Panels - Scratch &amp; Dent - Medium / Rear Gate - Scratch - Small / (R) Side Gate - Scratch - Medium / (R) Front Door, Molding - Scratch - Medium / (R) Front Fender, Molding - Scratch - Small / Front Bumper, Grille, Lamps - Scratch - Small / Bonnet, Headlight - Scratch - Small / (L) Front Fender, Molding - Repair mark - Yes</p>
