## General Information

Date & Time: 26, Jan, 2026 16:31

<b>Make</b>	Toyota	<b>Model</b>	Hiace
<b>YOM</b>	2025	<b>Odo Meter Reading</b>	6,358
<b>Registration No.</b>	BAH3295	<b>Chassis No.</b>	JTFJT02P4S0019862
<b>CC</b>	3.0	<b>Transmission</b>	M/T
<b>Fuel Type</b>	Diesel	<b>Type of Body</b>	Van
<b>Colour</b>	White

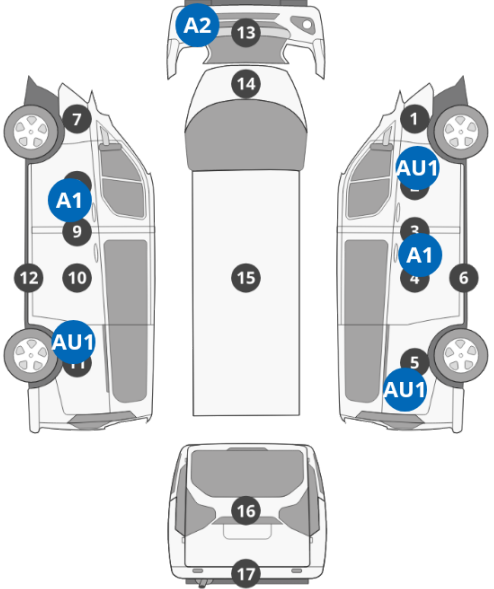
<p><b>A</b> : Scratch <b>AU</b> : Scratch &amp; Dent <b>B</b> : Modified <b>C</b> : Corrosion <b>G</b> : Stone chip <b>P</b> : Faded <b>S</b> : Rust <b>SC</b> : Rust &amp; Corrosion <b>U</b> : Dent <b>X</b> : Defective <b>Y</b> : Crack, Gap</p>
<b>Remarks</b> Defects not found	<b>Remarks</b> (R) Rear Door, Molding - Scratch - Minimal / (R) Front Door, Molding - Scratch & Dent - Minimal / (R) Rear Fender, Molding - Scratch & Dent - Minimal / (L) Rear Fender, Molding - Scratch & Dent - Minimal / (L) Front Door, Molding - Scratch - Minimal / Front Bumper, Grille, Lamps - Scratch - Small
