## General Information

<b>Make</b>	Toyota	<b>Model</b>	Hilux
<b>YOM</b>	2024	<b>Odo Meter Reading</b>	34,590
<b>Registration No.</b>	NKA9597	<b>Chassis No.</b>	MR0AB8DD3R5037488
<b>CC</b>	2.4	<b>Transmission</b>	A/T
<b>Fuel Type</b>	Diesel	<b>Type of Body</b>	Pickup
<b>Colour</b>	White

## Body / Panel Condition

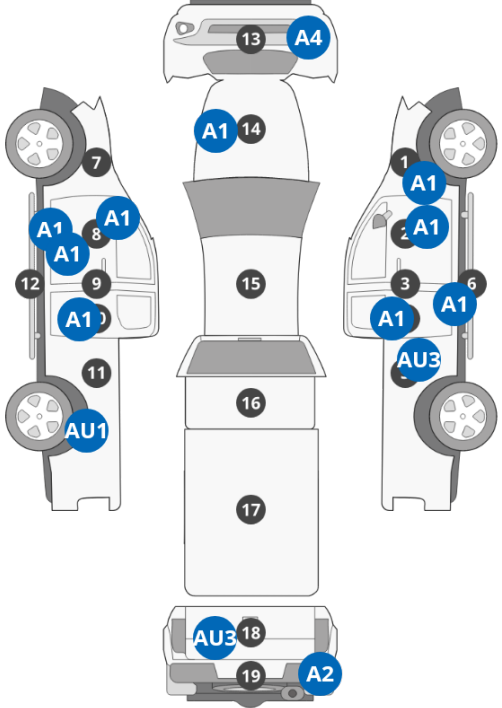
<p><b>A</b> : Scratch <b>AU</b> : Scratch &amp; Dent <b>B</b> : Modified <b>C</b> : Corrosion <b>G</b> : Stone chip <b>P</b> : Faded <b>S</b> : Rust <b>SC</b> : Rust &amp; Corrosion <b>U</b> : Dent <b>X</b> : Defective <b>Y</b> : Crack, Gap</p>
<b>Remarks</b> (L) Front Floor Mat - Missing - Yes	<b>Remarks</b> (R) Front Fender, Molding - Scratch - Minimal / (R) Front Door, Molding - Scratch - Minimal / (R) Step, In-panel, Side Spoiler - Scratch - Minimal / (R) Rear Door, Molding - Scratch - Minimal / (R) Side Gate - Scratch & Dent - Medium / Rear Bumper, Lamps, Panels - Scratch - Small / Rear Gate - Scratch & Dent - Medium / (L) Side Gate - Scratch & Dent - Minimal / (L) Rear Door, Molding - Scratch - Minimal / (L) Step, In-panel, Side Spoiler - Scratch - Minimal / (L) Front Door, Molding - Scratch - Minimal / (L) Mirror - Scratch - Minimal / Front Bumper, Grille, Lamps - Scratch - Large / Bonnet, Headlight - Scratch - Minimal
