## General Information

Date & Time: 26, Jan, 2026 18:35

<b>Make</b>	Toyota	<b>Model</b>	Hilux Tamaraw
<b>YOM</b>	2025	<b>Odo Meter Reading</b>	9,003
<b>Registration No.</b>	NKQ8944	<b>Chassis No.</b>	PAHACACA1S6425061
<b>CC</b>	2.4	<b>Transmission</b>	M/T
<b>Fuel Type</b>	Diesel	<b>Type of Body</b>	Utility Vehicle
<b>Colour</b>	White

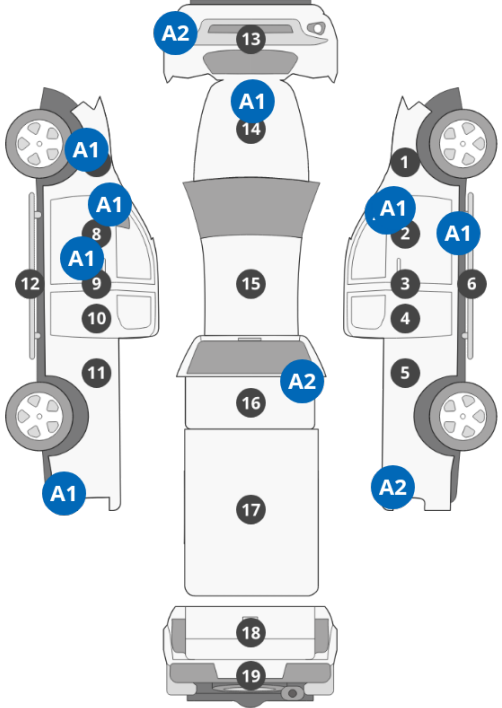
<p><b>A</b> : Scratch <b>AU</b> : Scratch &amp; Dent <b>B</b> : Modified <b>C</b> : Corrosion <b>G</b> : Stone chip <b>P</b> : Faded <b>S</b> : Rust <b>SC</b> : Rust &amp; Corrosion <b>U</b> : Dent <b>X</b> : Defective <b>Y</b> : Crack, Gap</p>
<b>Remarks</b> Defects not found	<b>Remarks</b> (R) Mirror - Scratch - Minimal / (R) Step, In-panel, Side Spoiler - Scratch - Minimal / (R) Front Door, Molding - Scratch - Minimal / Roof - Scratch - Small / (R) Side Gate - Scratch - Small / (L) Side Gate - Scratch - Minimal / (L) Front Door, Molding - Scratch - Minimal / (L) Mirror - Scratch - Minimal / (L) Front Fender, Molding - Scratch - Minimal / Front Bumper, Grille, Lamps - Scratch - Small / Bonnet, Headlight - Scratch - Minimal

<b>Inspector Notes</b>
With Lto plate, with warranty booklet, with spare tire and jack, 2keys, no tools, scratches on headlights and taillights
