## General Information

<b>Make</b>	Toyota	<b>Model</b>	Vios
<b>YOM</b>	2025	<b>Odo Meter Reading</b>	9,721
<b>Registration No.</b>	NJC9137	<b>Chassis No.</b>	PA1B18F39S4290969
<b>CC</b>	1.3	<b>Transmission</b>	CVT
<b>Fuel Type</b>	Gas	<b>Type of Body</b>	Sedan
<b>Colour</b>	Black

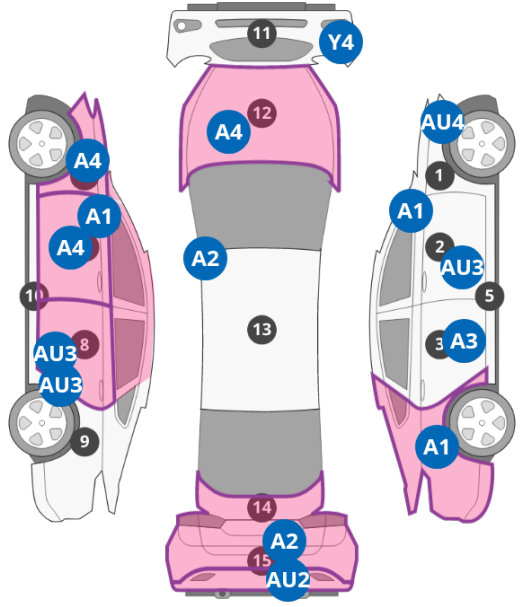
<p><b>A</b> : Scratch <b>AU</b> : Scratch &amp; Dent <b>B</b> : Modified <b>C</b> : Corrosion <b>G</b> : Stone chip <b>P</b> : Faded <b>S</b> : Rust <b>SC</b> : Rust &amp; Corrosion <b>U</b> : Dent <b>X</b> : Defective <b>Y</b> : Crack, Gap</p>
<b>Remarks</b> (R) Front Floor Mat - Missing - Yes / (L) Front Floor Mat - Missing - Yes / Mat Other - Missing - Yes	<b>Remarks</b> (L) Front Fender - Repair Traces - Yes / (L) Front Door - Repair Traces - Yes / (L) Rear Door - Repair Traces - Yes / (R) Front Fender, Molding - Scratch & Dent - Large / (R) Mirror - Scratch - Minimal / (R) Front Door, Molding - Scratch & Dent - Medium / (R) Rear Door, Molding - Scratch - Medium / (R) Rear Fender, Molding - Repair mark - Difference in Color / (R) Rear Fender, Molding - Scratch - Minimal / Rear Bumper, Lamps, Panels - Repair mark - Yes / Rear Bumper, Lamps, Panels - Scratch & Dent - Small / Trunk Hood, Rear Gate - Repair mark - Yes / Trunk Hood, Rear Gate - Scratch - Small / (L) Rear Fender, Molding - Scratch & Dent - Medium / (L) Rear Door, Molding - Repair mark - Difference in Color / (L) Rear Door, Molding - Scratch & Dent - Medium / (L) Front Door, Molding - Repair mark - Difference in Color / (L) Mirror - Scratch - Minimal / (L) Front Door, Molding - Scratch - Large / (L) Front Fender, Molding - Repair mark - Difference in Color / (L) Front Fender, Molding - Scratch - Large / Roof - Scratch - Small / Bonnet, Headlight - Repair mark - Difference in Color / Bonnet, Headlight - Scratch - Large / Front Bumper, Grille, Lamps - Crack, Gap - Large
