General Information

Make	Suzuki	Model	Ertiga
YOM	2023	Odo Meter Reading	32,541
Registration No.	GNW1523	Chassis No.	MHYNC32S5RJ100207
CC	1.5	Transmission	A/T
Fuel Type	Gas	Type of Body	Wagon
Colour	Silver

Body / Panel Condition

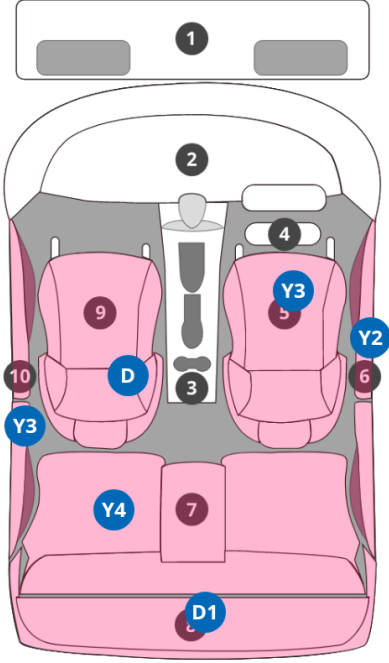
Interior Evaluation : C	Exterior Evaluation : B

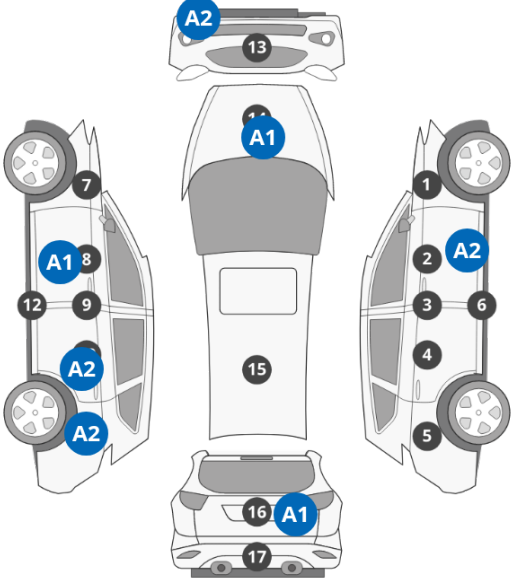
<p>A : Scratch AU : Scratch & Dent B : Modified C : Corrosion G : Stone chip P : Faded S : Rust SC : Rust & Corrosion U : Dent X : Defective Y : Crack, Gap</p>
<p>Remarks (L) Rear Trim - Grime - Medium / (L) Front Seat - Worn - Yes / (R) Front Seat - Grime - Medium / (R) Front Trim - Grime - Small / Rear Seat - Grime - Large / Trunk Room - Worked - Minimal</p>	<p>Remarks Roof - Repair Traces - Yes / (R) Rear Door, Molding - Scratch - Small / (L) Front Door, Molding - Scratch - Minimal / (L) Rear Door, Molding - Scratch - Small / (L) Rear Fender, Molding - Scratch - Small / Bonnet, Headlight - Scratch - Minimal / Trunk Hood, Rear Gate - Scratch - Minimal / Front Bumper, Grille, Lamps - Scratch - Small</p>
Frame Evaluation : A	Functional Evaluation : B
