General Information

Date & Time: 30, Jan, 2026 13:18

Make	Toyota	Model	Hilux Tamaraw
YOM	2025	Odo Meter Reading	5,863
Registration No.	GBK7251	Chassis No.	PAHACACA8S6422982
CC	2.4	Transmission	M/T
Fuel Type	Diesel	Type of Body	Utility Vehicle
Colour	White

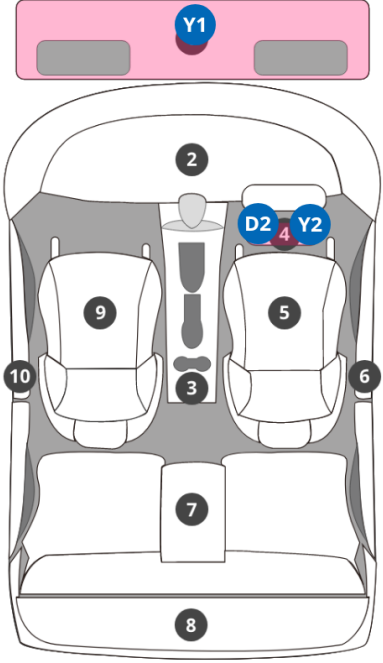
Interior Evaluation : A	Exterior Evaluation : C

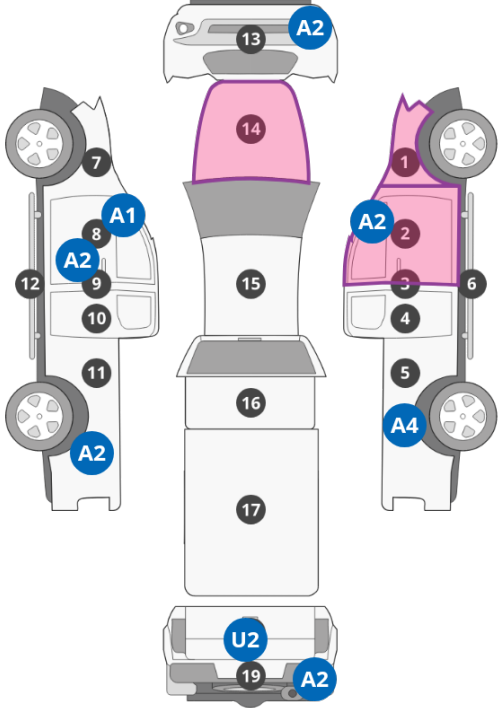
<p>A : Scratch AU : Scratch & Dent B : Modified C : Corrosion G : Stone chip P : Faded S : Rust SC : Rust & Corrosion U : Dent X : Defective Y : Crack, Gap</p>
<p>Remarks (L) Front Floor Mat - Worked - Small / Ceiling - Grime - Minimal / (R) Front Floor Mat - Grime - Small</p>	<p>Remarks (R) Front Door - Repair Traces - Yes / (R) Front Fender - Repair Traces - Yes / Bonnet - Repair Traces - Yes / (L) Rear Corner Panel - Repair Traces - Yes / (R) Front Fender, Molding - Repair mark - Yes / (R) Mirror - Scratch - Small / (R) Front Door, Molding - Repair mark - Yes / (R) Side Gate - Scratch - Large / Rear Gate - Dent - Small / Rear Bumper, Lamps, Panels - Scratch - Small / (L) Front Door, Molding - Scratch - Small / (L) Side Gate - Scratch - Small / (L) Mirror - Scratch - Minimal / Front Bumper, Grille, Lamps - Scratch - Small / Bonnet, Headlight - Repair mark - Yes</p>

<p>Inspector Notes</p>
<p>Front right fender repaired With warranty booklet and spare tire. Without jack and tools. 1 key. No LTO plate.</p>
