General Information

Make	Toyota	Model	Vios
YOM	2024	Odo Meter Reading	15,450
Registration No.	GBE1945	Chassis No.	PA1B18F33R4249943
CC	1.3	Transmission	CVT
Fuel Type	Gas	Type of Body	Sedan
Colour	Blue

Body / Panel Condition

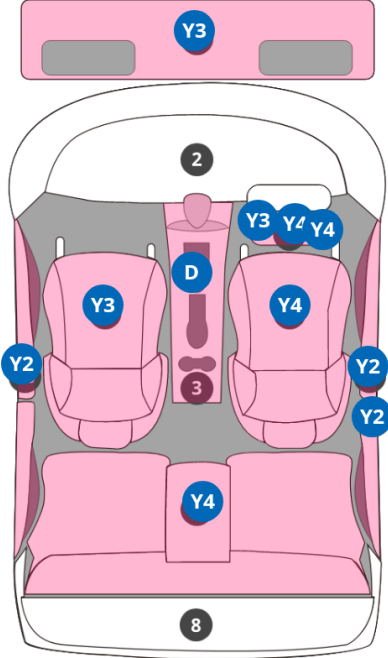
Interior Evaluation : E	Exterior Evaluation : E

<p>a : Cut, Fray d : Loose, Deformed k : Animal Hair s : Smell t : Cigarette Burns x : Defective y : Stain</p>

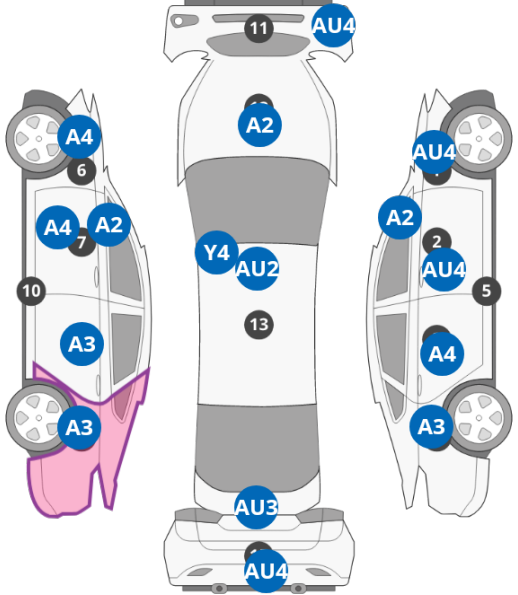
<p>A : Scratch AU : Scratch & Dent B : Modified C : Corrosion G : Stone chip P : Faded S : Rust SC : Rust & Corrosion U : Dent X : Defective Y : Crack, Gap</p>
Remarks (L) Front Trim - Grime - Small / (L) Front Floor Mat - Grime - Medium / Ceiling - Grime - Medium / (L) Front Seat - Grime - Medium / Rear Seat - Grime - Large / Mat Other - Grime - Large / (R) Rear Trim - Grime - Small / (R) Front Trim - Grime - Small / (R) Front Seat - Grime - Large / (R) Front Floor Mat - Grime - Large / Console, Switches, Vents - Traces of Adhesive Tape - Yes	Remarks (R) Step - Repair Traces - Yes / (L) Rear Door - Repair Traces - Yes / (L) Rear Fender - Repair Traces - Yes / Front Bumper, Grille, Lamps - Scratch & Dent - Large / (R) Front Fender, Molding - Scratch & Dent - Large / (R) Mirror - Scratch - Small / (R) Front Door, Molding - Scratch & Dent - Large / (R) Rear Door, Molding - Scratch - Large / (R) Rear Fender, Molding - Scratch - Medium / Trunk Hood, Rear Gate - Scratch & Dent - Medium / Rear Bumper, Lamps, Panels - Scratch & Dent - Large / (L) Rear Fender, Molding - Scratch - Medium / (L) Rear Door, Molding - Scratch - Medium / (L) Front Door, Molding - Scratch - Large / (L) Mirror - Scratch - Small / (L) Front Fender, Molding - Scratch - Large / Bonnet, Headlight - Scratch - Small / Roof - Scratch & Dent - Small / Front Windshield - Damaged - Large / (L) Rear Fender, Molding - Repair mark - Yes
