## General Information

<b>Make</b>	Toyota	<b>Model</b>	Vios
<b>YOM</b>	2024	<b>Odo Meter Reading</b>	8,560
<b>Registration No.</b>	GBE1656	<b>Chassis No.</b>	PA1B18F33R4252065
<b>CC</b>	1.3	<b>Transmission</b>	CVT
<b>Fuel Type</b>	Gas	<b>Type of Body</b>	Sedan
<b>Colour</b>	Silver

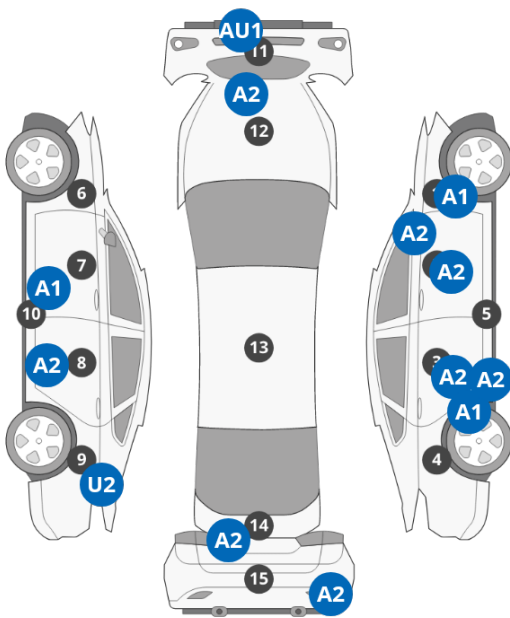
<p><b>A</b> : Scratch <b>AU</b> : Scratch &amp; Dent <b>B</b> : Modified <b>C</b> : Corrosion <b>G</b> : Stone chip <b>P</b> : Faded <b>S</b> : Rust <b>SC</b> : Rust &amp; Corrosion <b>U</b> : Dent <b>X</b> : Defective <b>Y</b> : Crack, Gap</p>
<p><b>Remarks</b> (L) Front Floor Mat - Cut, Crack - Small / (L) Front Trim - Grime - Small / Carpet - Loose, Deformed - Small / (L) Front Seat - Grime - Small / Mat Other - Grime - Large / Rear Seat - Grime - Large / (R) Front Floor Mat - Grime - Medium / (R) Front Trim - Grime - Small / Ceiling - Grime - Small / (R) Front Seat - Grime - Small</p>	<p><b>Remarks</b> (L) Rear Fender, Molding - Dent - Small / Trunk Hood, Rear Gate - Scratch - Small / Rear Bumper, Lamps, Panels - Scratch - Small / (R) Rear Door, Molding - Scratch - Small / (R) Rear Fender, Molding - Scratch - Minimal / (R) Mirror - Scratch - Small / (R) Front Door, Molding - Scratch - Small / (R) Front Fender, Molding - Scratch - Minimal / Bonnet, Headlight - Scratch - Small / Front Bumper, Grille, Lamps - Scratch &amp; Dent - Minimal / (L) Rear Door, Molding - Scratch - Small / (L) Front Door, Molding - Scratch - Minimal / (R) Step, In-panel, Side Spoiler - Scratch - Small</p>
