## General Information

Date & Time: 30, Jan, 2026 11:32

<b>Make</b>	Toyota	<b>Model</b>	Wigo
<b>YOM</b>	2025	<b>Odo Meter Reading</b>	5,023
<b>Registration No.</b>	CCQ1418	<b>Chassis No.</b>	MHKAA1BC9SJ039249
<b>CC</b>	1.0	<b>Transmission</b>	CVT
<b>Fuel Type</b>	Gas	<b>Type of Body</b>	Hatchback
<b>Colour</b>	Gray

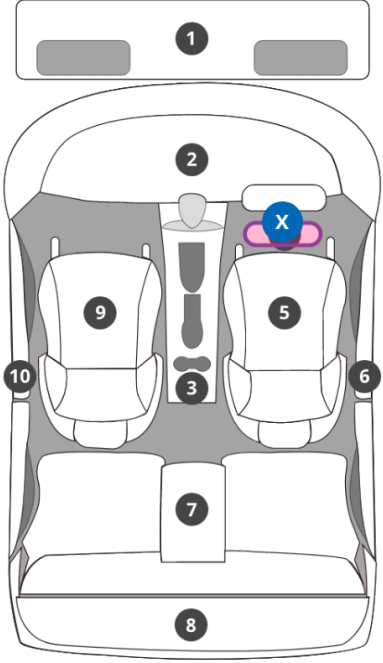
<b>Interior Evaluation :</b> <span style="float: right; color: red; font-weight: bold;">B</span>	<b>Exterior Evaluation :</b> <span style="float: right; color: red; font-weight: bold;">C</span>

<p><b>a</b> : Cut, Fray <b>d</b> : Loose, Deformed <b>k</b> : Animal Hair <b>s</b> : Smell <b>t</b> : Cigarette Burns <b>x</b> : Defective <b>y</b> : Stain</p>

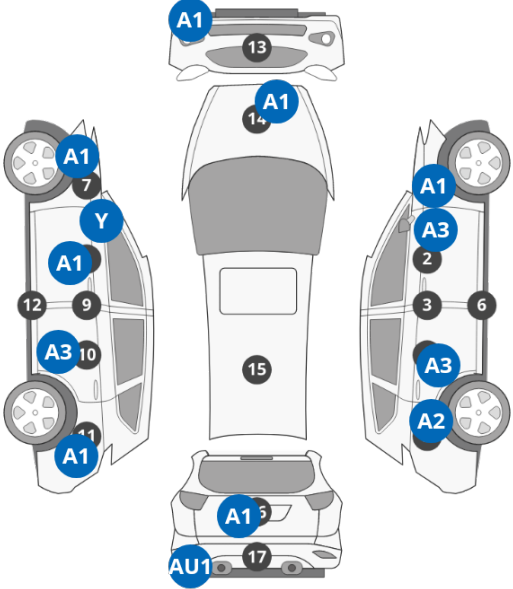
<p><b>A</b> : Scratch <b>AU</b> : Scratch &amp; Dent <b>B</b> : Modified <b>C</b> : Corrosion <b>G</b> : Stone chip <b>P</b> : Faded <b>S</b> : Rust <b>SC</b> : Rust &amp; Corrosion <b>U</b> : Dent <b>X</b> : Defective <b>Y</b> : Crack, Gap</p>
<b>Remarks</b> Mat Other - Missing - Yes	<b>Remarks</b> (R) Front Fender, Molding - Scratch - Minimal / (R) Front Door, Molding - Scratch - Medium / (R) Rear Door, Molding - Scratch - Medium / (R) Rear Fender, Molding - Scratch - Small / Rear Bumper, Lamps, Panels - Scratch & Dent - Minimal / Trunk Hood, Rear Gate - Scratch - Minimal / (L) Rear Fender, Molding - Scratch - Minimal / (L) Rear Door, Molding - Scratch - Medium / (L) Front Door, Molding - Scratch - Minimal / (L) Mirror - Crack - Cracks / (L) Front Fender, Molding - Scratch - Minimal / Front Bumper, Grille, Lamps - Scratch - Minimal / Bonnet, Headlight - Scratch - Minimal

<b>Inspector Notes</b>
With Lto plate ,with warranty booklet, with spare tire and jack, 1key, no tools, scratches on headlights and taillights
