General Information

Make	Suzuki	Model	Dzire
YOM	2019	Odo Meter Reading	85,421
Registration No.	NBT6853	Chassis No.	MA3ZF63S6KA470680
CC	1.2	Transmission	A/T
Fuel Type	Gas	Type of Body	Sedan
Colour	Blue

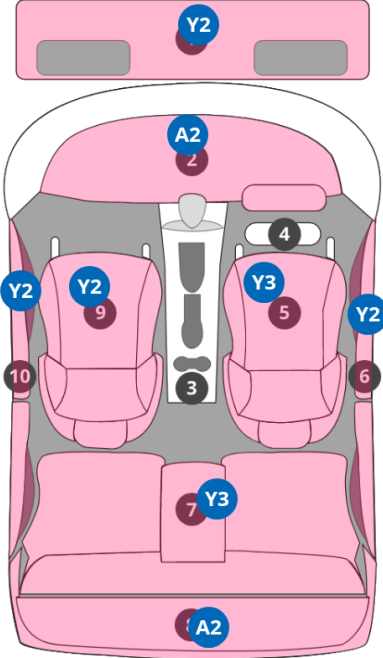
Interior Evaluation : C	Exterior Evaluation : E

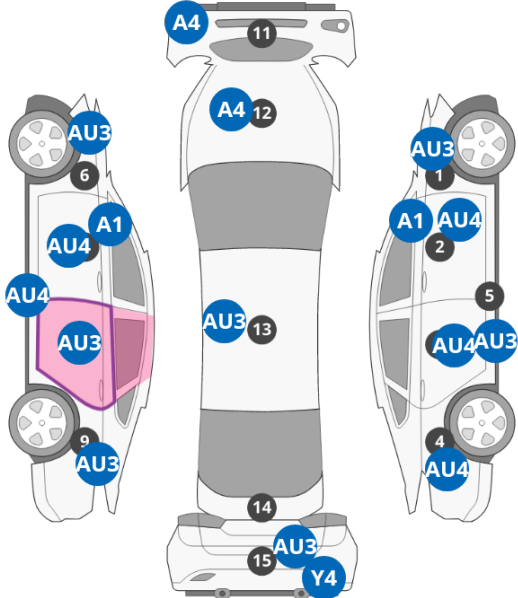
<p>A : Scratch AU : Scratch & Dent B : Modified C : Corrosion G : Stone chip P : Faded S : Rust SC : Rust & Corrosion U : Dent X : Defective Y : Crack, Gap</p>
<p>Remarks (R) Front Seat - Grime - Medium / (R) Front Trim - Grime - Small / Rear Seat - Grime - Medium / Trunk Room - Worn, Scratch, Cut, Crack - Small / (L) Front Trim - Grime - Small / (L) Front Seat - Grime - Small / Ceiling - Grime - Small / Dashboard - Worn, Scratch, Cut, Crack - Small</p>	<p>Remarks (L) Rear Door - Repair Traces - Yes / (L) Rear Door, Molding - Repair mark - Yes / (L) Front Door, Molding - Scratch & Dent - Large / (L) Step, In-panel, Side Spoiler - Scratch & Dent - Large / (L) Rear Door, Molding - Scratch & Dent - Medium / (L) Rear Fender, Molding - Scratch & Dent - Medium / Trunk Hood, Rear Gate - Scratch & Dent - Medium / Rear Bumper, Lamps, Panels - Crack, Gap - Large / (R) Rear Fender, Molding - Scratch & Dent - Large / (R) Rear Door, Molding - Scratch & Dent - Large / (R) Step, In-panel, Side Spoiler - Scratch & Dent - Medium / (R) Front Door, Molding - Scratch & Dent - Large / (R) Mirror - Scratch - Minimal / (R) Front Fender, Molding - Scratch & Dent - Medium / Bonnet, Headlight - Scratch - Large / Front Bumper, Grille, Lamps - Scratch - Large / (L) Front Fender, Molding - Scratch & Dent - Medium / (L) Mirror - Scratch - Minimal / Roof - Scratch & Dent - Medium</p>
