## General Information

<b>Make</b>	Toyota	<b>Model</b>	Vios
<b>YOM</b>	2025	<b>Odo Meter Reading</b>	3,899
<b>Registration No.</b>	NKM8872	<b>Chassis No.</b>	PA1B18F3XS4282315
<b>CC</b>	1.3	<b>Transmission</b>	CVT
<b>Fuel Type</b>	Gas	<b>Type of Body</b>	Sedan
<b>Colour</b>	Red Mica Metallic

## Body / Panel Condition

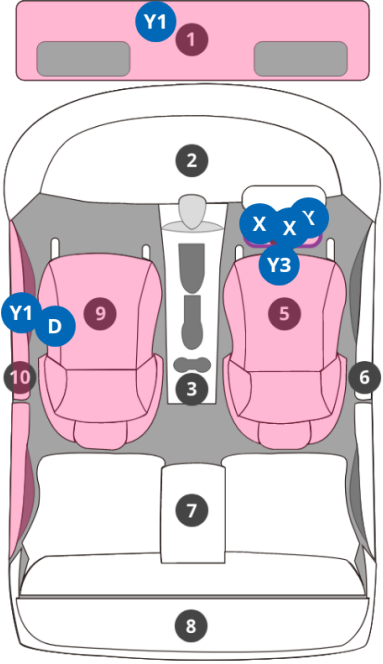
<b>Interior Evaluation :</b> <span style="float: right; color: red; font-weight: bold;">B</span>	<b>Exterior Evaluation :</b> <span style="float: right; color: red; font-weight: bold;">C</span>

<p><b>a</b> : Cut, Fray <b>d</b> : Loose, Deformed <b>k</b> : Animal Hair <b>s</b> : Smell <b>t</b> : Cigarette Burns <b>x</b> : Defective <b>y</b> : Stain</p>

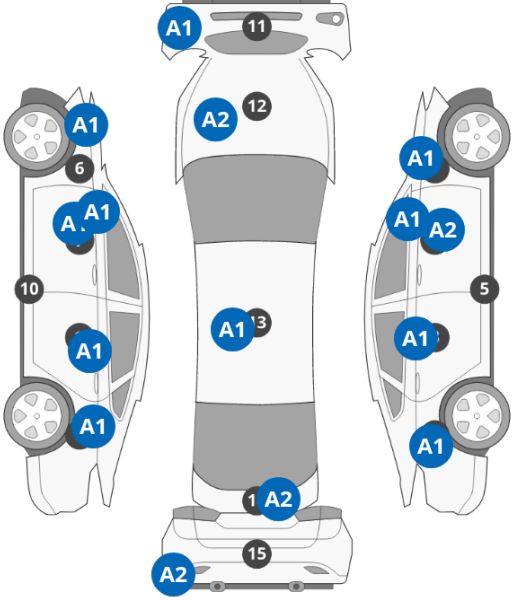
<p><b>A</b> : Scratch <b>AU</b> : Scratch &amp; Dent <b>B</b> : Modified <b>C</b> : Corrosion <b>G</b> : Stone chip <b>P</b> : Faded <b>S</b> : Rust <b>SC</b> : Rust &amp; Corrosion <b>U</b> : Dent <b>X</b> : Defective <b>Y</b> : Crack, Gap</p>
<p><b>Remarks</b> (L) Front Floor Mat - Missing - Yes / (R) Front Floor Mat - Missing - Yes / Mat Other - Missing - Yes / (L) Front Seat - Worn - Yes / (L) Front Trim - Grime - Minimal / Ceiling - Grime - Minimal / (R) Front Seat - Grime - Medium</p>	<p><b>Remarks</b> (R) Front Door, Molding - Scratch - Small / (R) Mirror - Scratch - Minimal / (R) Front Fender, Molding - Scratch - Minimal / (R) Rear Door, Molding - Scratch - Minimal / (R) Rear Fender, Molding - Scratch - Minimal / Trunk Hood, Rear Gate - Scratch - Small / Rear Bumper, Lamps, Panels - Scratch - Small / (L) Rear Fender, Molding - Scratch - Minimal / (L) Rear Door, Molding - Scratch - Minimal / (L) Front Door, Molding - Scratch - Minimal / (L) Mirror - Scratch - Minimal / (L) Front Fender, Molding - Scratch - Minimal / Front Bumper, Grille, Lamps - Scratch - Minimal / Bonnet, Headlight - Scratch - Small / Roof - Scratch - Minimal / Overall Exterior - Worn as per age - Yes</p>
