General Information

Make	Toyota	Model	Vios
YOM	2024	Odo Meter Reading	74,362
Registration No.	DBJ9775	Chassis No.	PA1B18F36P4227562
CC	1.3	Transmission	CVT
Fuel Type	Gas	Type of Body	Sedan
Colour	Green

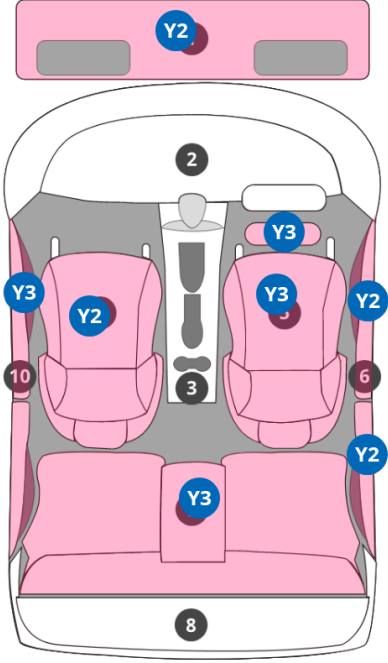
Interior Evaluation : C	Exterior Evaluation : E

<p>a : Cut, Fray d : Loose, Deformed k : Animal Hair s : Smell t : Cigarette Burns x : Defective y : Stain</p>

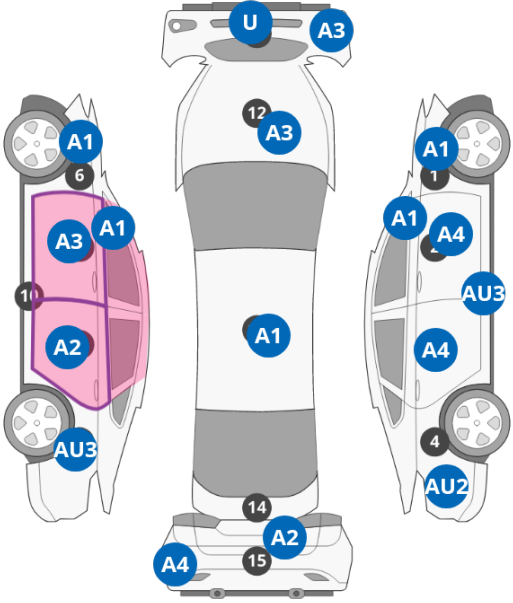
<p>A : Scratch AU : Scratch & Dent B : Modified C : Corrosion G : Stone chip P : Faded S : Rust SC : Rust & Corrosion U : Dent X : Defective Y : Crack, Gap</p>
<p>Remarks (R) Front Seat - Grime - Medium / (R) Front Trim - Grime - Small / Rear Seat - Grime - Medium / (R) Rear Trim - Grime - Small / (L) Front Trim - Grime - Medium / (L) Front Floor Mat - Grime - Medium / (L) Front Seat - Grime - Small / Ceiling - Grime - Small</p>	<p>Remarks (R) Front Door - Repair Traces - Yes / (R) Front Fender - Repair Traces - Yes / (L) Front Door - Repair Traces - Yes / (L) Rear Door - Repair Traces - Yes / (R) Rear Fender - Repair Traces - Yes / (R) Rear Door - Repair Traces - Yes / Roof - Repair Traces - Yes / (L) Rear Fender, Molding - Scratch & Dent - Medium / (L) Front Door, Molding - Repair mark - Yes / (L) Rear Door, Molding - Repair mark - Yes / (L) Rear Door, Molding - Scratch - Small / (L) Mirror - Scratch - Minimal / (L) Front Door, Molding - Scratch - Medium / (L) Front Fender, Molding - Scratch - Minimal / Front Bumper, Grille, Lamps - Scratch - Medium / Bonnet, Headlight - Scratch - Medium / (R) Front Fender, Molding - Scratch - Minimal / (R) Mirror - Scratch - Minimal / (R) Front Door, Molding - Scratch - Large / (R) Rear Door, Molding - Scratch - Large / (R) Rear Fender, Molding - Scratch & Dent - Small / (R) Step, In-panel, Side Spoiler - Scratch & Dent - Medium / Trunk Hood, Rear Gate - Scratch - Small / Rear Bumper, Lamps, Panels - Scratch - Large / Roof - Scratch - Minimal / Member (Bolted) - Dent - Yes</p>
