## General Information

<b>Make</b>	Toyota	<b>Model</b>	Vios
<b>YOM</b>	2024	<b>Odo Meter Reading</b>	11,399
<b>Registration No.</b>	DBP2069	<b>Chassis No.</b>	PA1B18F3XR4261295
<b>CC</b>	1.3	<b>Transmission</b>	CVT
<b>Fuel Type</b>	Gas	<b>Type of Body</b>	Sedan
<b>Colour</b>	Silver

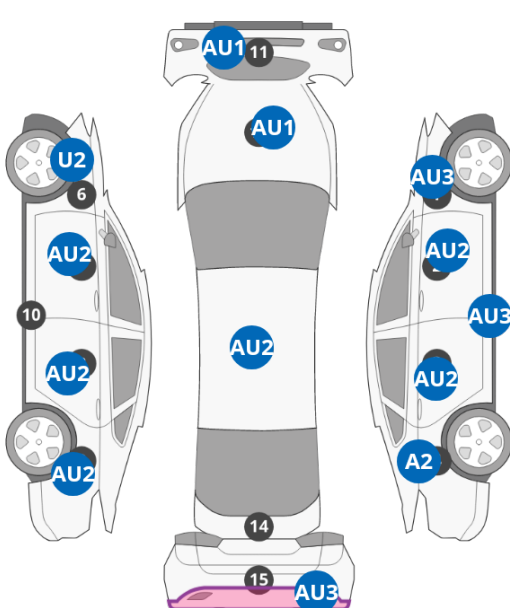
<p><b>A</b> : Scratch <b>AU</b> : Scratch &amp; Dent <b>B</b> : Modified <b>C</b> : Corrosion <b>G</b> : Stone chip <b>P</b> : Faded <b>S</b> : Rust <b>SC</b> : Rust &amp; Corrosion <b>U</b> : Dent <b>X</b> : Defective <b>Y</b> : Crack, Gap</p>
<p><b>Remarks</b>  (R) Front Floor Mat - Missing - Yes / (L) Front Floor Mat - Missing - Yes / Mat Other - Missing - Yes / (L) Front Seat - Grime - Small / (R) Front Seat - Grime - Minimal / Rear Seat - Grime - Small / (L) Front Trim - Grime - Small / (R) Front Trim - Grime - Minimal / Ceiling - Grime - Small</p>	<p><b>Remarks</b>  Roof - Scratch &amp; Dent - Small / (L) Front Door, Molding - Scratch &amp; Dent - Small / (L) Rear Door, Molding - Scratch &amp; Dent - Small / (L) Rear Fender, Molding - Scratch &amp; Dent - Small / Rear Bumper, Lamps, Panels - Scratch &amp; Dent - Medium / Rear Bumper, Lamps, Panels - Repair mark - Yes / (R) Rear Fender, Molding - Scratch - Small / (R) Rear Door, Molding - Scratch &amp; Dent - Small / (R) Step, In-panel, Side Spoiler - Scratch &amp; Dent - Medium / (R) Front Door, Molding - Scratch &amp; Dent - Small / (R) Front Fender, Molding - Scratch &amp; Dent - Medium / Bonnet, Headlight - Scratch &amp; Dent - Minimal / (L) Front Fender, Molding - Dent - Small / Front Bumper, Grille, Lamps - Scratch &amp; Dent - Minimal</p>
