## General Information

<b>Make</b>	Toyota	<b>Model</b>	Raize
<b>YOM</b>	2024	<b>Odo Meter Reading</b>	31,704
<b>Registration No.</b>	DBP2595	<b>Chassis No.</b>	MHKAB1BA9RJ090952
<b>CC</b>	1.2	<b>Transmission</b>	CVT
<b>Fuel Type</b>	Gas	<b>Type of Body</b>	SUV
<b>Colour</b>	Gray

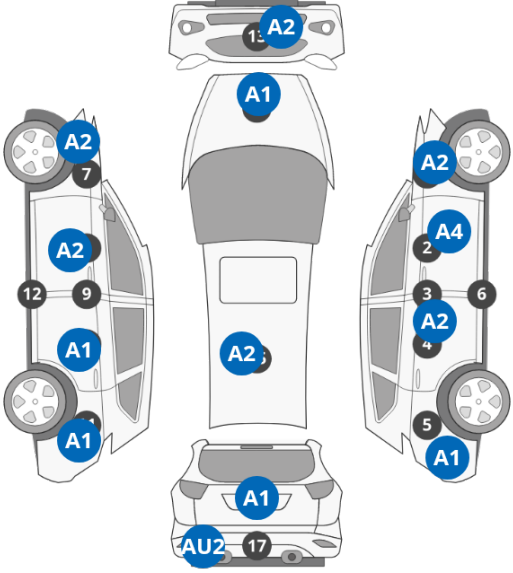
<p><b>A</b> : Scratch <b>AU</b> : Scratch &amp; Dent <b>B</b> : Modified <b>C</b> : Corrosion <b>G</b> : Stone chip <b>P</b> : Faded <b>S</b> : Rust <b>SC</b> : Rust &amp; Corrosion <b>U</b> : Dent <b>X</b> : Defective <b>Y</b> : Crack, Gap</p>
<p><b>Remarks</b> (R) Front Seat - Grime - Medium / Rear Seat - Grime - Medium / (L) Front Seat - Grime - Small / Ceiling - Grime - Small</p>	<p><b>Remarks</b> (L) Rear Door, Molding - Scratch - Minimal / (L) Rear Fender, Molding - Scratch - Minimal / Rear Bumper, Lamps, Panels - Scratch &amp; Dent - Small / Trunk Hood, Rear Gate - Scratch - Minimal / (R) Rear Door, Molding - Scratch - Small / (R) Rear Fender, Molding - Scratch - Minimal / (R) Front Door, Molding - Scratch - Large / (R) Front Fender, Molding - Scratch - Small / Bonnet, Headlight - Scratch - Minimal / Front Bumper, Grille, Lamps - Scratch - Small / (L) Front Fender, Molding - Scratch - Small / (L) Front Door, Molding - Scratch - Small / Roof - Scratch - Small</p>
