## General Information

<b>Make</b>	Toyota	<b>Model</b>	Vios
<b>YOM</b>	2024	<b>Odo Meter Reading</b>	41,493
<b>Registration No.</b>	DBP2690	<b>Chassis No.</b>	PA1B18F34R4255007
<b>CC</b>	1.3	<b>Transmission</b>	CVT
<b>Fuel Type</b>	Gas	<b>Type of Body</b>	Sedan
<b>Colour</b>	Silver

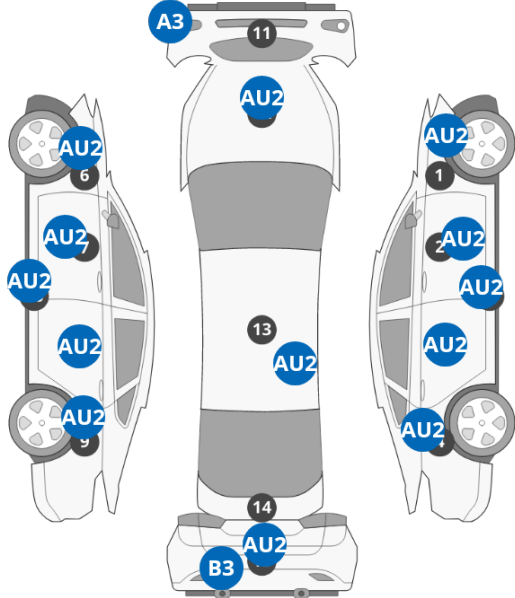
<p><b>A</b> : Scratch <b>AU</b> : Scratch &amp; Dent <b>B</b> : Modified <b>C</b> : Corrosion <b>G</b> : Stone chip <b>P</b> : Faded <b>S</b> : Rust <b>SC</b> : Rust &amp; Corrosion <b>U</b> : Dent <b>X</b> : Defective <b>Y</b> : Crack, Gap</p>
<p><b>Remarks</b> (L) Front Floor Mat - Grime - Medium / (L) Front Seat - Grime - Small / (R) Front Seat - Grime - Minimal / Rear Seat - Grime - Minimal / Ceiling - Grime - Minimal / (L) Front Trim - Grime - Minimal / (R) Front Trim - Grime - Minimal / Dashboard - Traces of Adhesive Tape - Yes</p>	<p><b>Remarks</b> (R) Front Fender, Molding - Scratch &amp; Dent - Small / (R) Front Door, Molding - Scratch &amp; Dent - Small / (R) Rear Door, Molding - Scratch &amp; Dent - Small / (R) Step, In-panel, Side Spoiler - Scratch &amp; Dent - Small / Roof - Scratch &amp; Dent - Small / (R) Rear Fender, Molding - Scratch &amp; Dent - Small / Trunk Hood, Rear Gate - Scratch &amp; Dent - Small / Rear Bumper, Lamps, Panels - Modified - Medium / (L) Rear Fender, Molding - Scratch &amp; Dent - Small / (L) Rear Door, Molding - Scratch &amp; Dent - Small / (L) Front Door, Molding - Scratch &amp; Dent - Small / (L) Step, In-panel, Side Spoiler - Scratch &amp; Dent - Small / (L) Front Fender, Molding - Scratch &amp; Dent - Small / Bonnet, Headlight - Scratch &amp; Dent - Small / Front Bumper, Grille, Lamps - Scratch - Medium</p>
