## General Information

<b>Make</b>	Toyota	<b>Model</b>	Vios
<b>YOM</b>	2025	<b>Odo Meter Reading</b>	3,990
<b>Registration No.</b>	DBU7129	<b>Chassis No.</b>	PA1B18F35S4287132
<b>CC</b>	1.3	<b>Transmission</b>	CVT
<b>Fuel Type</b>	Gas	<b>Type of Body</b>	Sedan
<b>Colour</b>	Red Mica Metallic

## Body / Panel Condition

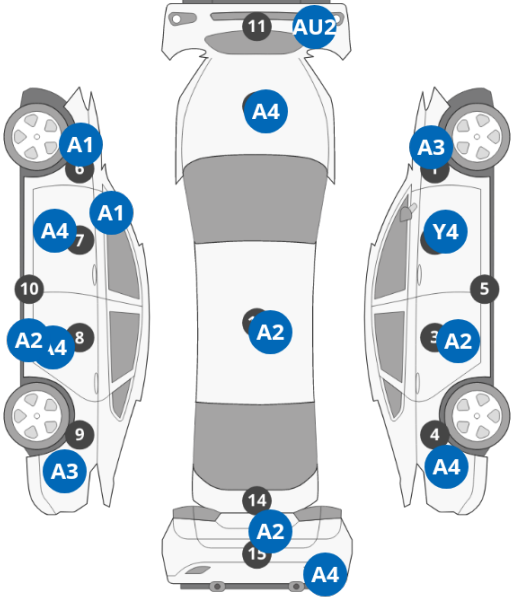
<p><b>A</b> : Scratch <b>AU</b> : Scratch &amp; Dent <b>B</b> : Modified <b>C</b> : Corrosion <b>G</b> : Stone chip <b>P</b> : Faded <b>S</b> : Rust <b>SC</b> : Rust &amp; Corrosion <b>U</b> : Dent <b>X</b> : Defective <b>Y</b> : Crack, Gap</p>
<p><b>Remarks</b> (R) Front Seat - Grime - Medium / Ceiling - Grime - Small / Console, Switchs, Vents - Worn, Scratch, Cut, Crack - Small / (L) Front Seat - Grime - Small / (L) Front Trim - Grime - Medium / Rear Seat - Grime - Small</p>	<p><b>Remarks</b> (L) Front Door, Molding - Scratch - Large / (L) Rear Door, Molding - Scratch - Large / (L) Step, In-panel, Side Spoiler - Scratch - Small / (L) Rear Fender, Molding - Scratch - Medium / (L) Mirror - Scratch - Minimal / (L) Front Fender, Molding - Scratch - Minimal / Bonnet, Headlight - Scratch - Large / Front Bumper, Grille, Lamps - Scratch &amp; Dent - Small / (R) Front Fender, Molding - Scratch - Medium / (R) Front Door, Molding - Crack, Gap - Large / (R) Rear Door, Molding - Scratch - Small / (R) Rear Fender, Molding - Scratch - Large / Rear Bumper, Lamps, Panels - Scratch - Large / Trunk Hood, Rear Gate - Scratch - Small / Roof - Scratch - Small</p>
