General Information

| Make | Toyota | Model | Vios |
| Registration No. | NEY7601 | Chassis No. | PA1B18F36R4263139 |

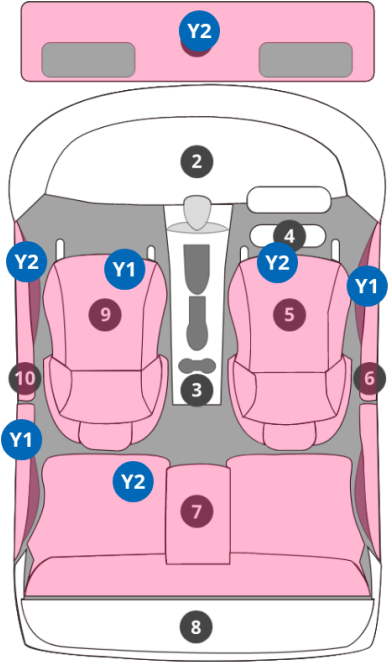
| Interior Evaluation : B | Exterior Evaluation : B |
| <p>Remarks (R) Front Trim - Grime - Minimal / (R) Front Seat - Grime - Small / Rear Seat - Grime - Small / (L) Rear Trim - Grime - Minimal / (L) Front Trim - Grime - Small / (L) Front Seat - Grime - Minimal / Ceiling - Grime - Small</p> | <p>Remarks Roof - Scratch & Dent - Small / Trunk Hood, Rear Gate - Scratch - Small / (L) Rear Fender, Molding - Scratch - Minimal / (L) Mirror - Scratch - Minimal / Bonnet, Headlight - Scratch - Minimal / Front Bumper, Grille, Lamps - Scratch - Medium / (R) Front Fender, Molding - Scratch - Small / (R) Front Door, Molding - Scratch - Minimal / (R) Rear Door, Molding - Scratch - Minimal / Rear Bumper, Lamps, Panels - Scratch - Medium / (L) Rear Door, Molding - Scratch - Minimal</p> |
