## General Information

Date & Time: 03, Feb, 2026 19:01

<b>Make</b>	Toyota	<b>Model</b>	Vios
<b>YOM</b>	2024	<b>Odo Meter Reading</b>	40,255
<b>Registration No.</b>	NHS1673	<b>Chassis No.</b>	PA1B18F32P4233357
<b>CC</b>	1.3	<b>Transmission</b>	CVT
<b>Fuel Type</b>	Gas	<b>Type of Body</b>	Sedan
<b>Colour</b>	Blue

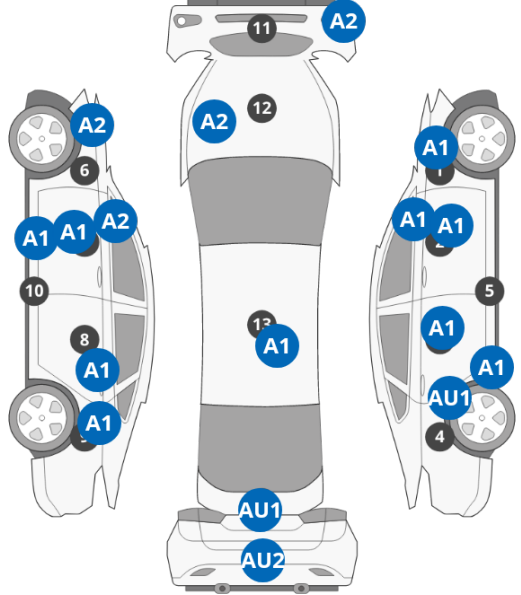
<p><b>A</b> : Scratch <b>AU</b> : Scratch &amp; Dent <b>B</b> : Modified <b>C</b> : Corrosion <b>G</b> : Stone chip <b>P</b> : Faded <b>S</b> : Rust <b>SC</b> : Rust &amp; Corrosion <b>U</b> : Dent <b>X</b> : Defective <b>Y</b> : Crack, Gap</p>
<p><b>Remarks</b> (L) Front Trim - Grime - Minimal / (L) Front Seat - Grime - Medium / (R) Front Seat - Grime - Small / (R) Front Trim - Grime - Minimal / Ceiling - Grime - Small / Rear Seat - Grime - Small / (L) Front Floor Mat - Worked - Large / (L) Front Floor Mat - Cut, Crack - Small</p>	<p><b>Remarks</b> (R) Mirror - Scratch - Minimal / (R) Front Fender, Molding - Scratch - Minimal / (R) Step, In-panel, Side Spoiler - Scratch - Minimal / (R) Front Door, Molding - Scratch - Minimal / (R) Rear Door, Molding - Scratch - Minimal / (R) Rear Fender, Molding - Scratch &amp; Dent - Minimal / Rear Bumper, Lamps, Panels - Scratch &amp; Dent - Small / Trunk Hood, Rear Gate - Scratch &amp; Dent - Minimal / (L) Rear Fender, Molding - Scratch - Minimal / (L) Rear Door, Molding - Scratch - Minimal / (L) Step, In-panel, Side Spoiler - Scratch - Minimal / (L) Front Door, Molding - Scratch - Minimal / (L) Mirror - Scratch - Small / (L) Front Fender, Molding - Scratch - Small / Front Bumper, Grille, Lamps - Scratch - Small / Bonnet, Headlight - Scratch - Small / Roof - Scratch - Minimal</p>
