General Information

Make	Toyota	Model	Vios
YOM	2023	Odo Meter Reading	116,005
Registration No.	NIG7473	Chassis No.	PA1B18F32N4199305
CC	1.3	Transmission	CVT
Fuel Type	Gas	Type of Body	Sedan
Colour	Black

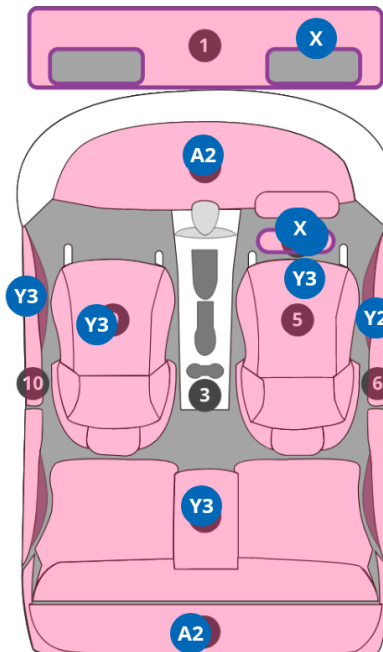
Interior Evaluation : C	Exterior Evaluation : E

<p>a : Cut, Fray d : Loose, Deformed k : Animal Hair s : Smell t : Cigarette Burns x : Defective y : Stain</p>

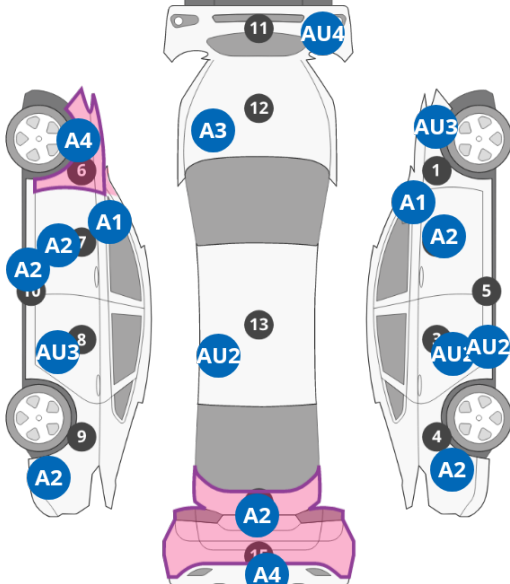
<p>A : Scratch AU : Scratch & Dent B : Modified C : Corrosion G : Stone chip P : Faded S : Rust SC : Rust & Corrosion U : Dent X : Defective Y : Crack, Gap</p>
<p>Remarks (R) Front Seat - Grime - Medium / (R) Front Trim - Grime - Small / Rear Seat - Grime - Medium / (L) Front Trim - Grime - Medium / (L) Front Seat - Grime - Medium / (R) Front Floor Mat - Missing - Yes / (L) Front Floor Mat - Missing - Yes / Mat Other - Missing - Yes / Trunk Room - Worn, Scratch, Cut, Crack - Small / Sunvisor, Sunglass Holder - Missing - Yes / Room Mirror - Missing - Yes / Dashboard - Worn, Scratch, Cut, Crack - Small</p>	<p>Remarks (L) Front Fender - Repair Traces - Yes / Trunk Hood, Rear Gate - Repair Traces - Yes / Roof - Scratch & Dent - Small / Front Bumper, Grille, Lamps - Scratch & Dent - Large / (L) Front Fender, Molding - Repair mark - Yes / Trunk Hood, Rear Gate - Repair mark - Yes / (R) Front Fender, Molding - Scratch & Dent - Medium / Bonnet, Headlight - Scratch - Medium / (L) Mirror - Scratch - Minimal / (L) Front Fender, Molding - Scratch - Large / (L) Front Door, Molding - Scratch - Small / (L) Rear Door, Molding - Scratch & Dent - Medium / (L) Rear Fender, Molding - Scratch - Small / Trunk Hood, Rear Gate - Scratch - Small / Rear Bumper, Lamps, Panels - Scratch - Large / (R) Rear Fender, Molding - Scratch - Small / (R) Rear Door, Molding - Scratch & Dent - Small / (R) Step, In-panel, Side Spoiler - Scratch & Dent - Small / (R) Front Door, Molding - Scratch - Small / (L) Step, In-panel, Side Spoiler - Scratch - Small / (R) Mirror - Scratch - Minimal</p>
