General Information

| Make | Toyota | Model | Vios |
| YOM | 2024 | Odo Meter Reading | 11,053 |
| Registration No. | NIU6960 | Chassis No. | PA1B18F39P4237194 |

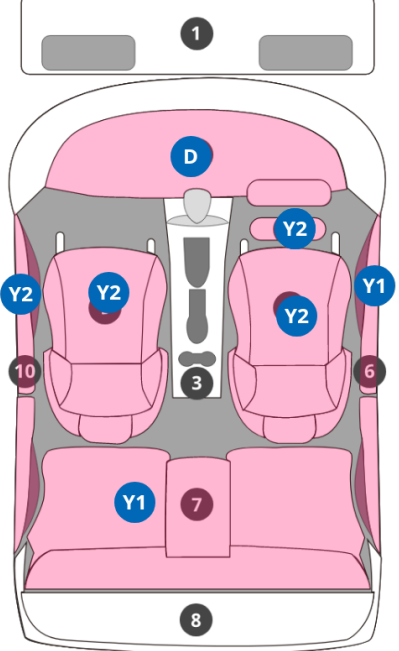
| Interior Evaluation : B | Exterior Evaluation : E |

| <p>Remarks (L) Front Floor Mat - Crinkle - Medium / (R) Front Floor Mat - Grime - Small / (L) Front Seat - Grime - Small / (R) Front Seat - Grime - Small / Rear Seat - Grime - Minimal / Dashboard - Traces of Adhesive Tape - Yes / (L) Front Trim - Grime - Small / (R) Front Trim - Grime - Minimal</p> | <p>Remarks Rear Bumper, Lamps, Panels - Modified - Medium / Trunk Hood, Rear Gate - Modified - Medium / Trunk Hood, Rear Gate - Scratch - Small / Rear Bumper, Lamps, Panels - Scratch - Small / (L) Rear Fender, Molding - Scratch - Medium / (L) Rear Door, Molding - Scratch & Dent - Small / (L) Front Door, Molding - Scratch & Dent - Small / Roof - Scratch & Dent - Small / (L) Step, In-panel, Side Spoiler - Scratch & Dent - Minimal / (L) Front Fender, Molding - Scratch & Dent - Small / Front Bumper, Grille, Lamps - Scratch - Medium / Bonnet, Headlight - Scratch & Dent - Small / (R) Front Fender, Molding - Scratch & Dent - Small / (R) Front Door, Molding - Scratch & Dent - Small / (R) Step, In-panel, Side Spoiler - Scratch & Dent - Small / (R) Rear Door, Molding - Scratch & Dent - Minimal / (R) Rear Fender, Molding - Scratch & Dent - Small</p> |
