## General Information

<b>Make</b>	Toyota	<b>Model</b>	Vios
<b>YOM</b>	2025	<b>Odo Meter Reading</b>	7,759
<b>Registration No.</b>	NKS5212	<b>Chassis No.</b>	PA1B18F31S4289413
<b>CC</b>	1.3	<b>Transmission</b>	CVT
<b>Fuel Type</b>	Gas	<b>Type of Body</b>	Sedan
<b>Colour</b>	Black

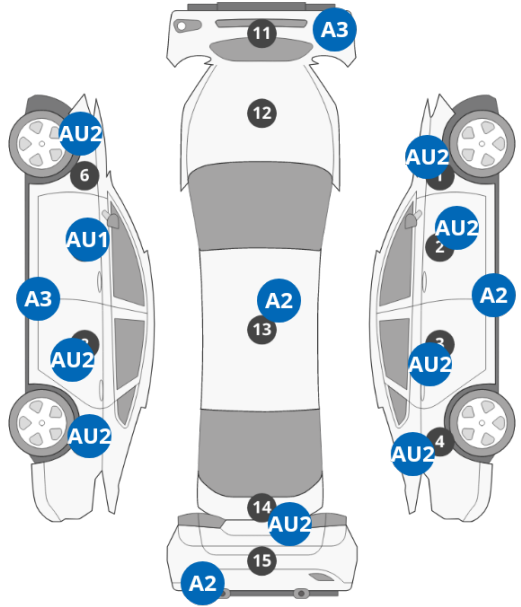
<p><b>A</b> : Scratch <b>AU</b> : Scratch &amp; Dent <b>B</b> : Modified <b>C</b> : Corrosion <b>G</b> : Stone chip <b>P</b> : Faded <b>S</b> : Rust <b>SC</b> : Rust &amp; Corrosion <b>U</b> : Dent <b>X</b> : Defective <b>Y</b> : Crack, Gap</p>
<p><b>Remarks</b> (L) Front Floor Mat - Grime - Medium / (L) Front Seat - Grime - Small / (R) Front Seat - Grime - Minimal / Rear Seat - Grime - Minimal / (L) Front Trim - Grime - Minimal / (R) Front Trim - Grime - Minimal</p>	<p><b>Remarks</b> (L) Front Door, Molding - Scratch &amp; Dent - Minimal / (L) Rear Door, Molding - Scratch &amp; Dent - Small / (L) Step, In-panel, Side Spoiler - Scratch - Medium / (L) Rear Fender, Molding - Scratch &amp; Dent - Small / Trunk Hood, Rear Gate - Scratch &amp; Dent - Small / Rear Bumper, Lamps, Panels - Scratch - Small / (R) Rear Fender, Molding - Scratch &amp; Dent - Small / (R) Rear Door, Molding - Scratch &amp; Dent - Small / (R) Front Door, Molding - Scratch &amp; Dent - Small / (R) Step, In-panel, Side Spoiler - Scratch - Small / Roof - Scratch - Small / (R) Front Fender, Molding - Scratch &amp; Dent - Small / Front Bumper, Grille, Lamps - Scratch - Medium / (L) Front Fender, Molding - Scratch &amp; Dent - Small</p>
