General Information

Date & Time: 05, Feb, 2026 15:45

Make	Suzuki	Model	S-Presso
YOM	2023	Odo Meter Reading	55,589
Registration No.	NIF5769	Chassis No.	MA3FL41S6PA377507
CC	1.0	Transmission	M/T
Fuel Type	Gas	Type of Body	Hatchback
Colour	Gray

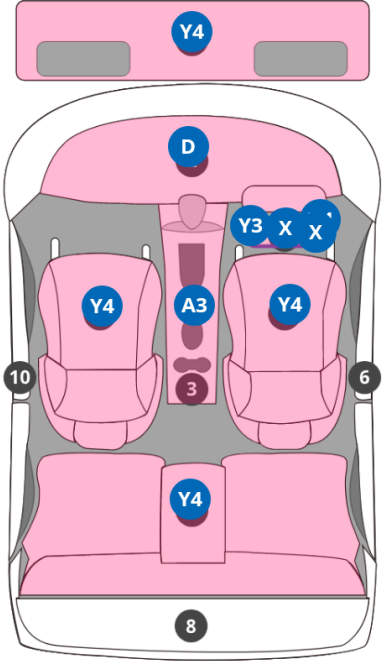
Interior Evaluation : E	Exterior Evaluation : E

<p>a : Cut, Fray d : Loose, Deformed k : Animal Hair s : Smell t : Cigarette Burns x : Defective y : Stain</p>

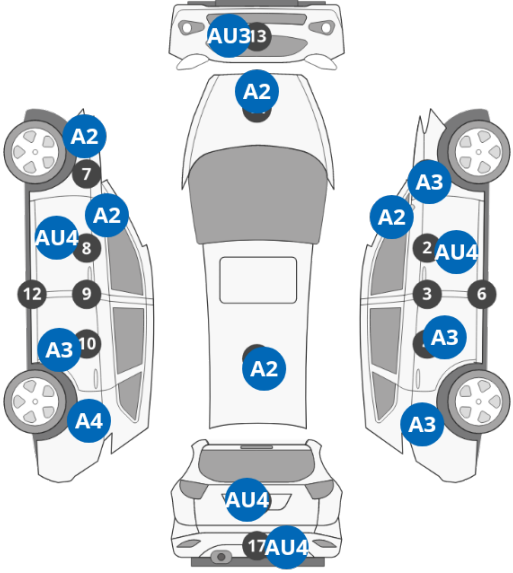
<p>A : Scratch AU : Scratch & Dent B : Modified C : Corrosion G : Stone chip P : Faded S : Rust SC : Rust & Corrosion U : Dent X : Defective Y : Crack, Gap</p>
Remarks (L) Front Seat - Grime - Large / (L) Front Floor Mat - Grime - Medium / Ceiling - Grime - Large / Mat Other - Missing - Yes / Rear Seat - Grime - Large / (R) Front Seat - Grime - Large / Carpet - Worked - Large / (R) Front Floor Mat - Missing - Yes / Knobs - Worn, Peel, Crack - Medium / Dashboard - Traces of Adhesive Tape - Yes	Remarks Rear End Panel - Repair Traces - Yes / (L) Mirror - Scratch - Small / (L) Front Door, Molding - Scratch & Dent - Large / (L) Front Fender, Molding - Scratch - Small / (L) Rear Door, Molding - Scratch - Medium / (L) Rear Fender, Molding - Scratch - Large / Trunk Hood, Rear Gate - Scratch & Dent - Large / Rear Bumper, Lamps, Panels - Scratch & Dent - Large / (R) Rear Fender, Molding - Scratch - Medium / (R) Rear Door, Molding - Scratch - Medium / (R) Front Door, Molding - Scratch & Dent - Large / (R) Mirror - Scratch - Small / (R) Front Fender, Molding - Scratch - Medium / Bonnet, Headlight - Scratch - Small / Front Bumper, Grille, Lamps - Scratch & Dent - Medium / Roof - Scratch - Small
